Review of likelihood of RAAC in Wheatley Group Properties

December 2023

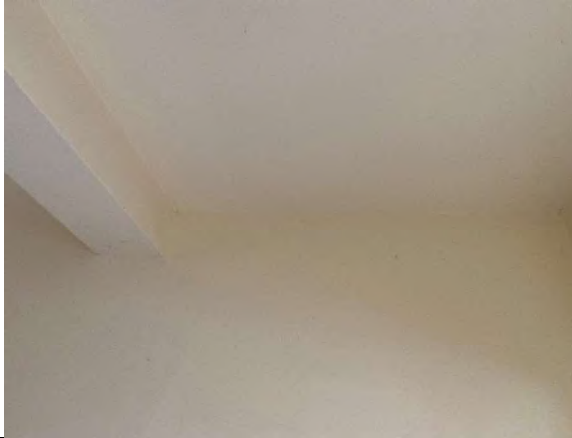
Conclusions for area 1	Based on an inspection within the common close area to the underside of the concrete ceiling there was no evidence of chamfers to identify RAAC, and a test using a screwdriver did not produce any indentations as would be expected in RAAC panels. This would have been 2 nd floor of former 4 storey block.
Area 2 inspected	Outer leaf rendered walls inspected.
Methods used for area 2	Review of the render finish and the location of vents
Conclusions for area 2	Vents noted below the render at ground floor level suggest that timber floor joists will be located at ground level. No sign of concrete noted.

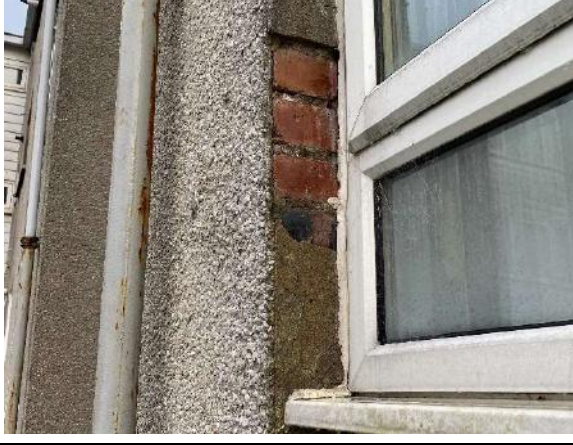
Conclusions for area 2	Clay brick is present below the render finish. A RAAC panel is not present.

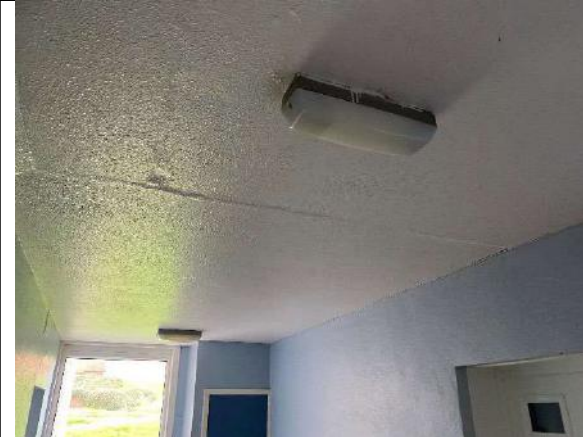
Conclusions for area 1	A test using a screwdriver did not produce any indentations as would be expected in RAAC panels, therefore likely construction finish is RC slabs to the roof.
Area 2 inspected	Outer leaf wall construction is visible from external elevation survey, brick at ground level and some small spalling of render at upper floor levels exposing brickwork.
Methods used for area 2	Visual inspection of External Elevations.
Evidence gathered for area 2

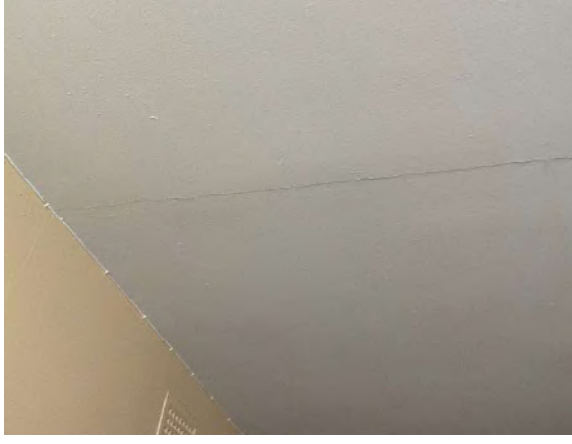
Conclusions for area 2	Solid concrete slabs noted throughout, precast stairs also note.

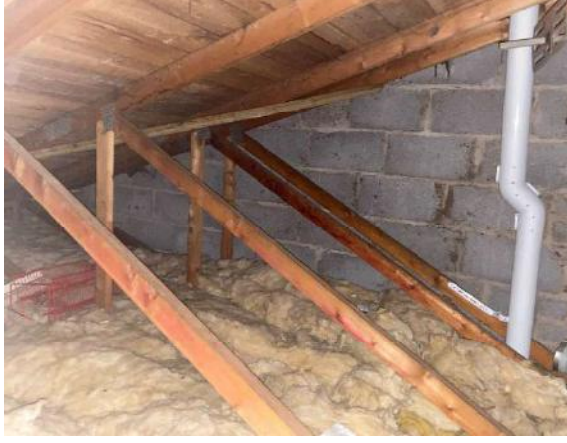
Conclusions for area 2	Block is present as the inner leaf of the main wall construction. RAAC panels are not present.

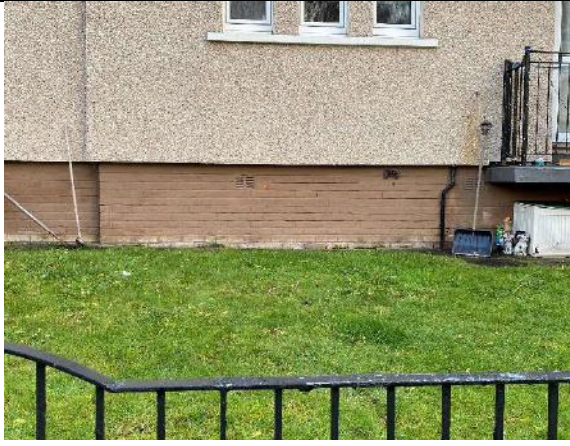
Conclusions for area 2	Clay brick vent is present below the EWI render finish. Concrete floors are not present.

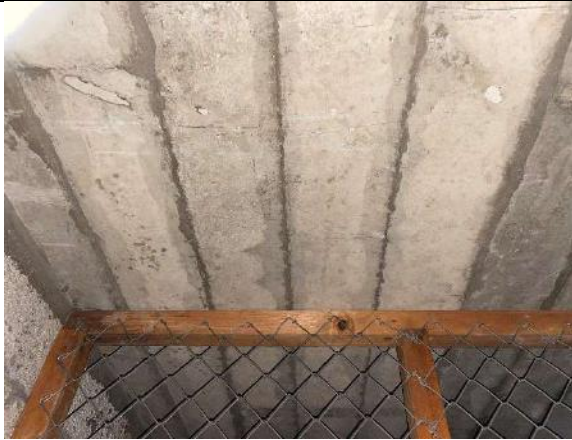
Conclusions for area 2	A series of precast concrete beams which span front to rear, 3.3m, and approximately 150mm wide. No chamfers noted in joints. Hammer test resulted in a solid "ping" with no hollow elements or indentations made in

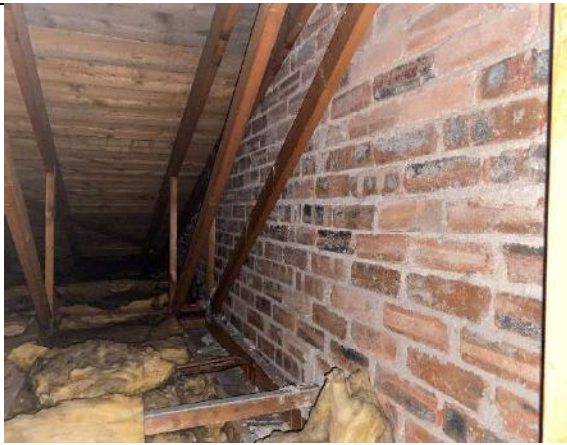
Conclusions for area 2	Clay brick is present as the inner leaf of the main wall construction. RAAC panels are not present.

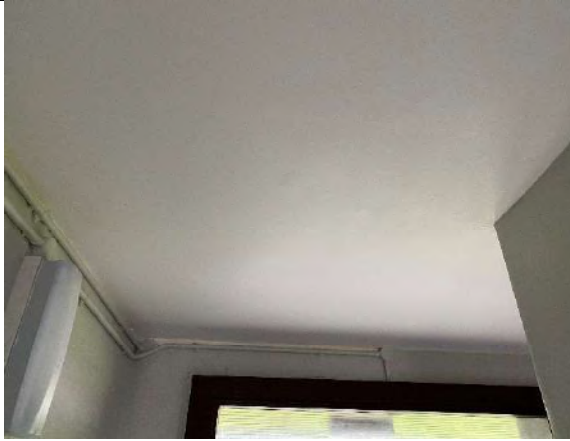
Conclusions for area 2	Solid concrete slabs noted at ground level, precast stairs also noted.

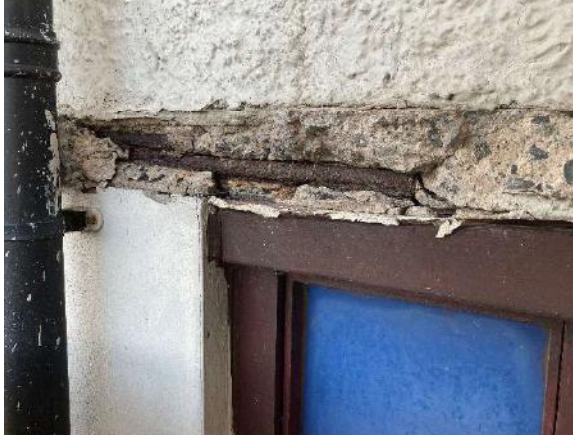
Conclusions for area 2	Reinforced concrete beams visible, concrete is solid with a “ping” confirming solid RC concrete

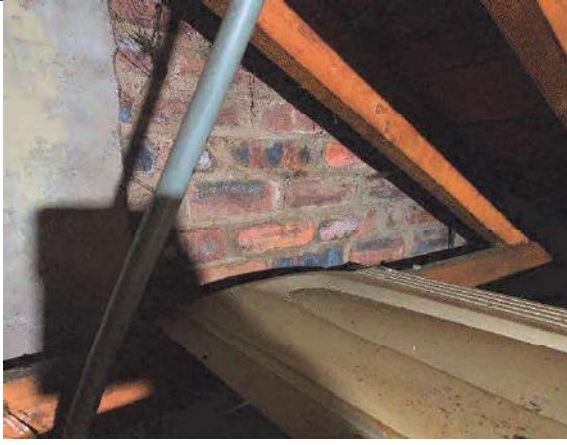
Conclusions for area 2	Clay brick is present as the inner leaf of the main wall construction. RAAC panels are not present.

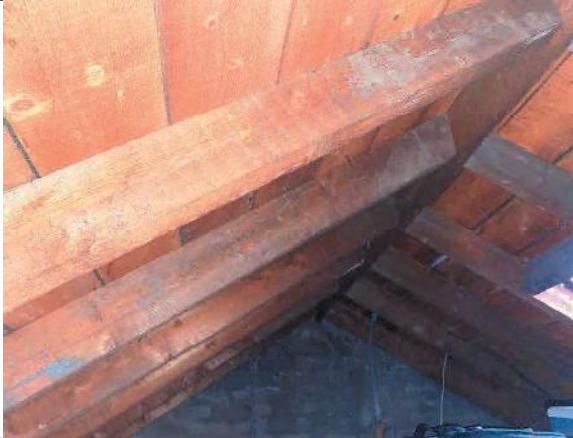
Conclusions for area 1	Timber trusses and timber ceiling ties are noted to the duo pitched roof. This confirms the use of structural timbers forming the main roof structure.
Area 2 inspected	Inner leaf of wall construction is visible from within attic space duo pitched roof section.
Methods used for area 2	Visual inspection of brick in attic space
Evidence gathered for area 2

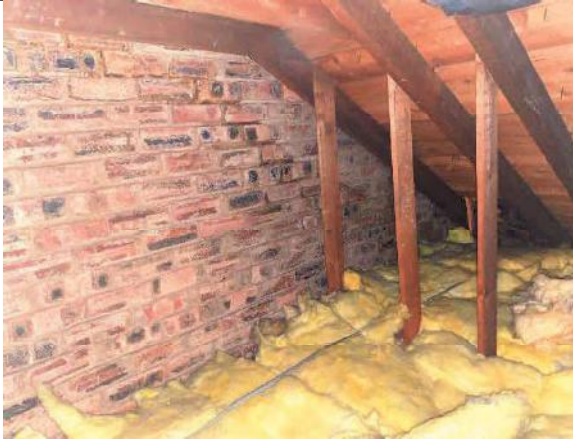
Conclusions for area 2	Clay brick is present as the inner leaf of the main wall construction. RAAC panels are not present.

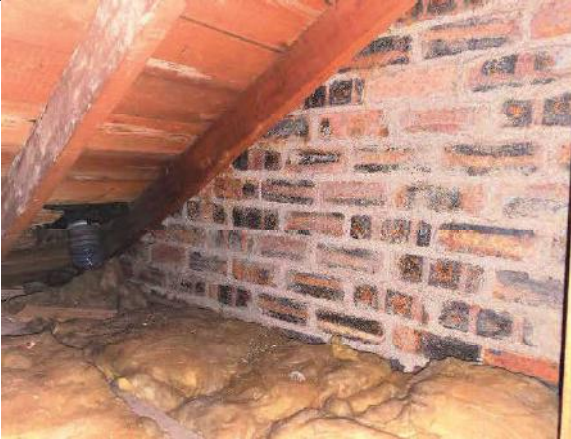
Conclusions for area 2	Clay brick is present as the inner leaf of the main wall construction. RAAC panels are not present.

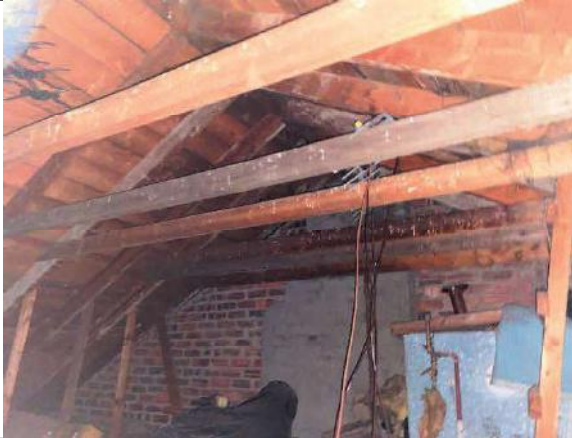
Conclusions for area 1	Timber trusses and timber ceiling ties are noted to the duo pitched roof. This confirms the use of structural timbers forming the main roof structure.
Area 2 inspected	Inner leaf of wall construction is visible from within attic space duo pitched roof section.
Methods used for area 2	Visual inspection of brick in attic space
Evidence gathered for area 2

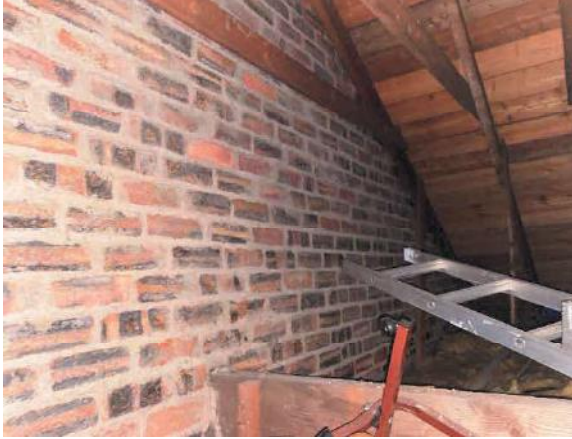
Conclusions for area 2	Clay brick is present as the inner leaf of the main wall construction. RAAC panels are not present.

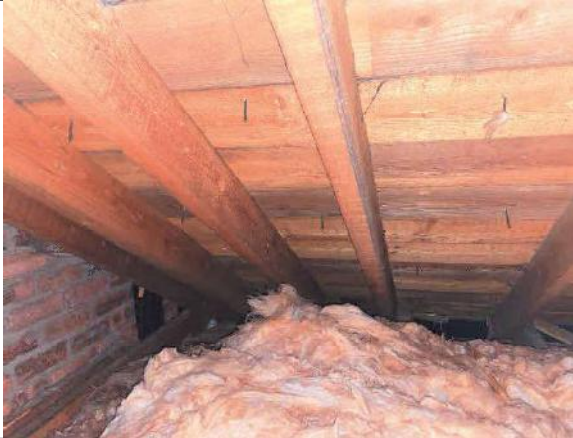
Conclusions for area 1	Timber trusses and timber ceiling ties are noted to the duo pitched roof. This confirms the use of structural timbers forming the main roof structure.
Area 2 inspected	Inner leaf of wall construction is visible from within attic space duo pitched roof section.
Methods used for area 2	Visual inspection of brick in attic space
Evidence gathered for area 2

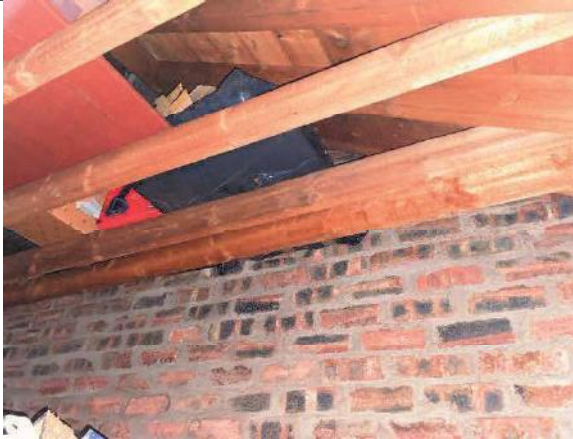
Conclusions for area 2	Clay brick is present as the inner leaf of the main wall construction. RAAC panels are not present.

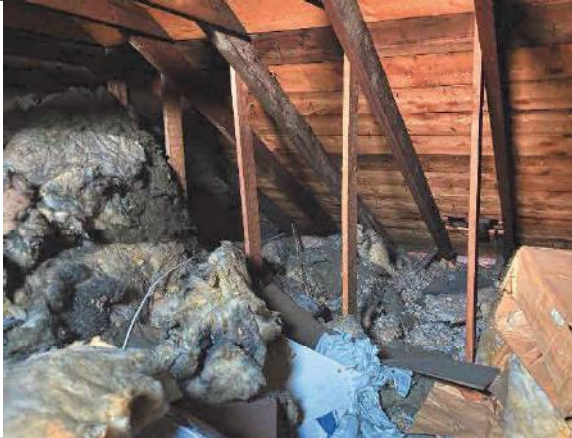
Conclusions for area 1	Timber trusses and timber ceiling ties are noted to the duo pitched roof. This confirms the use of structural timbers forming the main roof structure.
Area 2 inspected	Inner leaf of wall construction is visible from within attic space duo pitched roof section.
Methods used for area 2	Visual inspection of brick in attic space
Evidence gathered for area 2

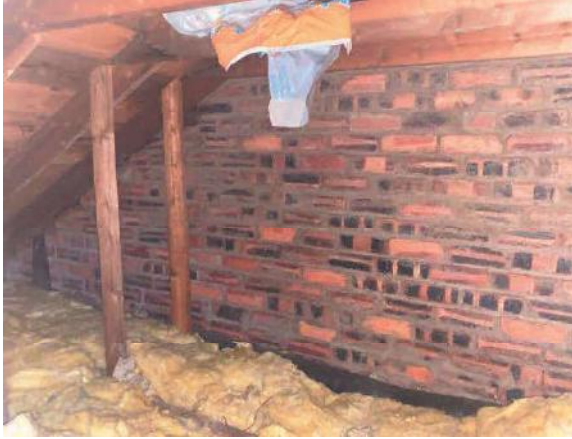
Conclusions for area 2	Clay brick is present as the inner leaf of the main wall construction. RAAC panels are not present.

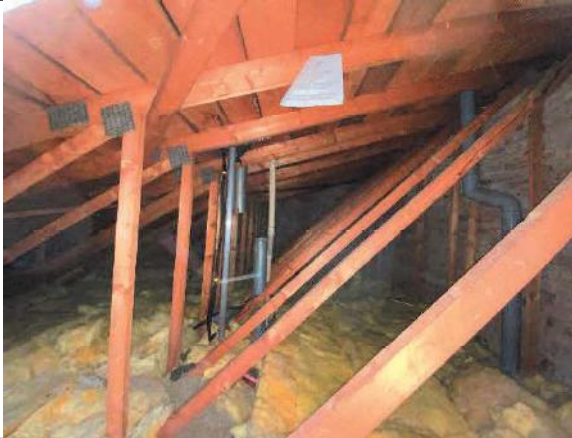
Conclusions for area 1	Timber rafters, timber struts and timber ceiling ties are noted to the mono pitched roof sections of the block. This confirms the use of structural timbers forming the main roof structure. Flat roof section above common close section with plaster finish also noted as timber joists.
Area 2 inspected	Inner leaf of wall construction is visible from within attic space of pitched roof section.
Methods used for area 2	Visual inspection of brick in attic space
Evidence gathered for area 2

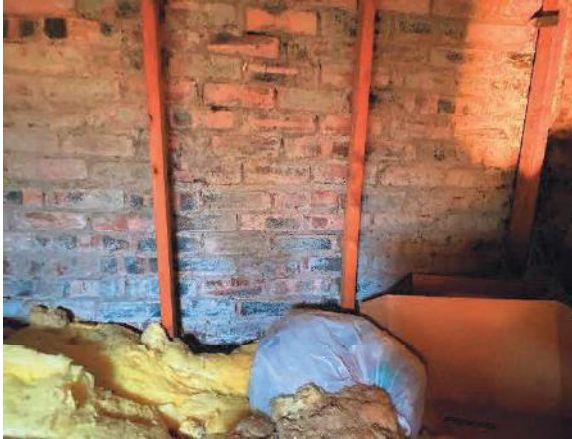
Conclusions for area 2	Clay brick is present as the inner leaf of the main wall construction. RAAC panels are not present.

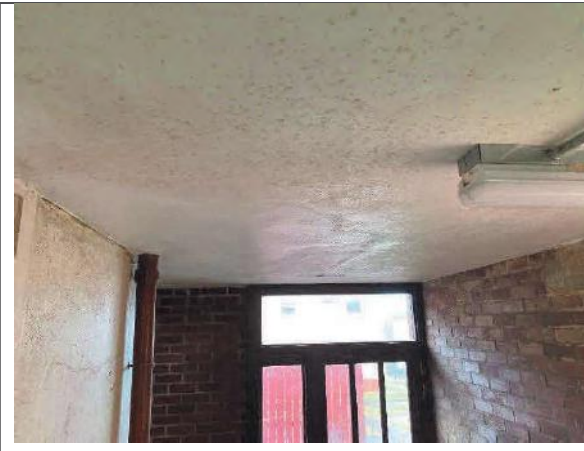
Conclusions for area 3	Reinforced concrete slab noted, hammer test confirmed a solid ping with no indentations made while inspecting. No RAAC concrete present.

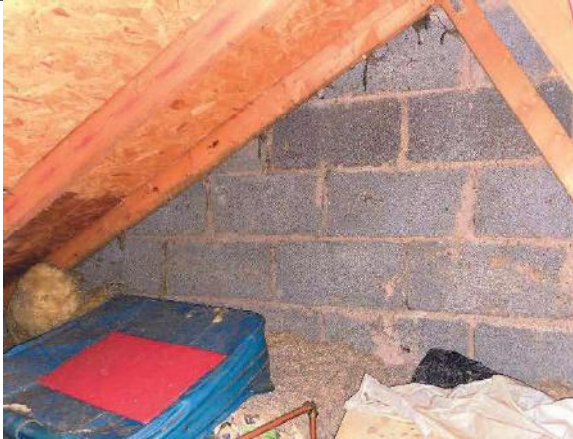
Conclusions for area 2	Blockwork is present as the party wall of the main wall construction. RAAC panels are not present.

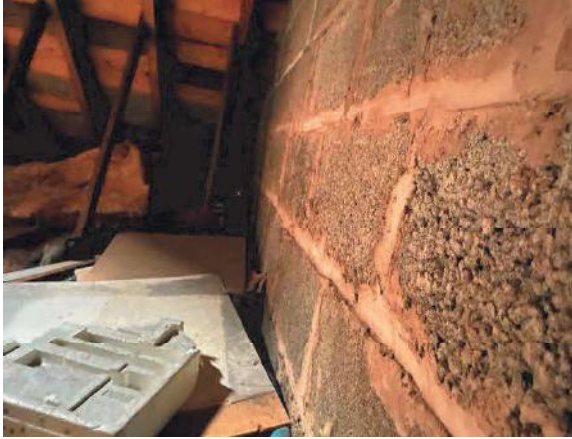
Conclusions for area 2	Blockwork is present as the inner leaf and party wall of the main wall construction. RAAC panels are not present.

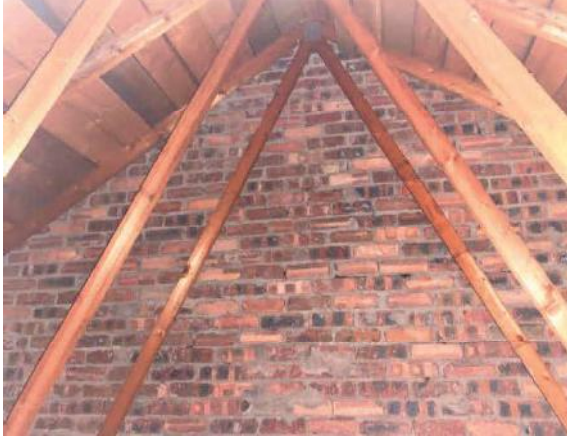
Conclusions for area 2	Clay brick is present as the external walls of the main wall construction. RAAC panels are not present.

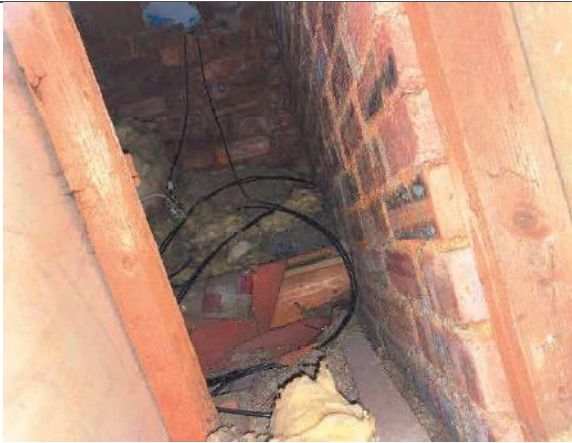
Conclusions for area 2	Clay brick is present as the party wall and inner leaf of the main wall construction. RAAC panels are not present.

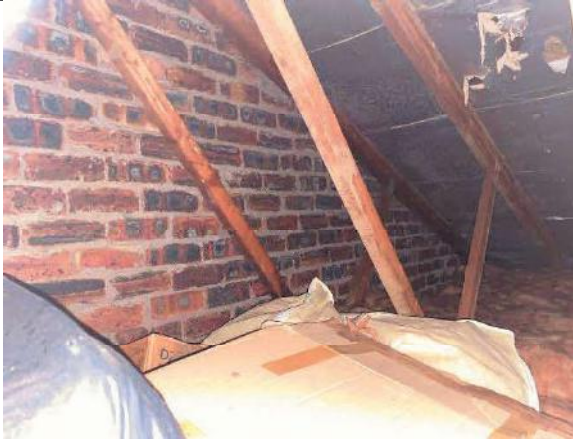
Conclusions for area 2	Clay brick is present as the external walls of the main wall construction. RAAC panels are not present.
