Review of likelihood of RAAC in Wheatley Group Properties

December 2023

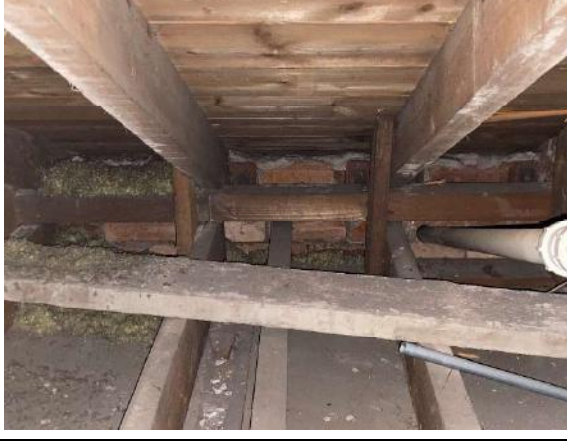
Conclusions for area 2	Clay brick is present as the inner leaf of the main wall construction. RAAC panels are not present.

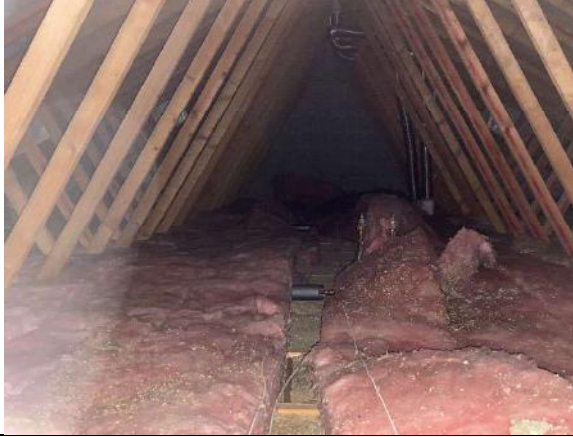
Conclusions for area 1	Fink truss timber truss arrangement noted to the duo pitched roof section of the block. This confirms the use of structural timbers forming the main roof structure.
Area 2 inspected	Inner leaf of wall construction is visible from within attic space of pitched roof section.
Methods used for area 2	Visual inspection of rendered walls to the external elevations of the block
Evidence gathered for area 2

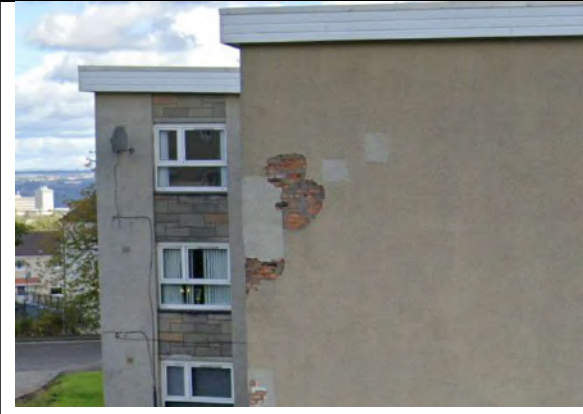
Conclusions for area 2	Clay brick is present as the outer leaf of the main wall construction. RAAC panels are not present.

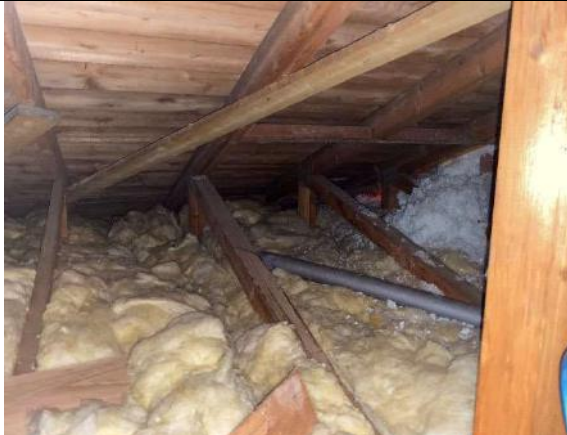
Conclusions for area 1	Timber rafters and timber ceiling ties are noted to the duo pitched roof of the house. This confirms the use of structural timbers forming the main roof structure.
Area 2 inspected	Inner leaf of wall construction is visible from within attic space of pitched roof section.
Methods used for area 2	Visual inspection of blockwork in attic space
Evidence gathered for area 2

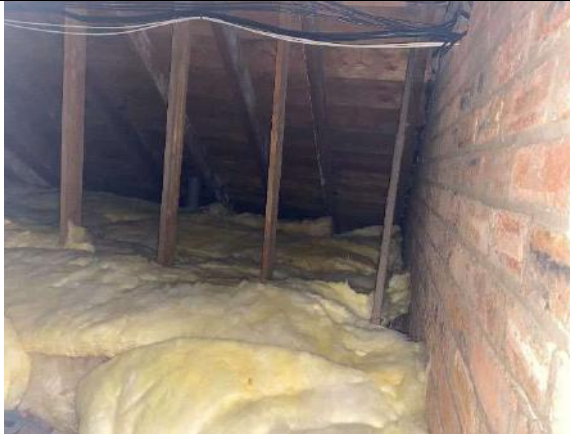
Conclusions for area 1	Timber rafters, timber struts and timber ceiling ties are noted to the duo pitched roof sections of the block. This confirms the use of structural timbers forming the main roof structure.
Area 2 inspected	Timber floors to all floors.
Methods used for area 2	External survey noting vents below render finish, and confirmation via historical drawings
Evidence gathered for area 2

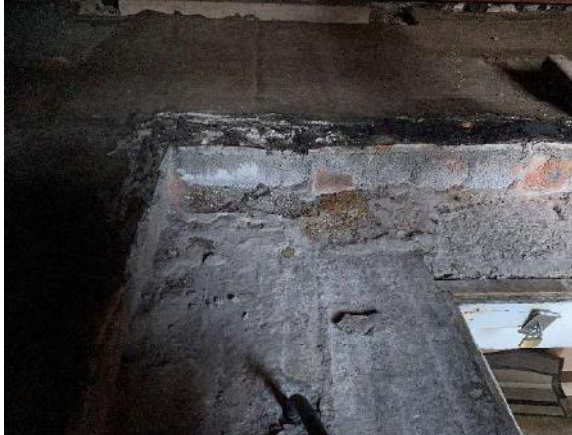
Conclusions for area 1	Original flat concrete roof with a screed, asphalted, above flat areas. The roof has since been overpitched with a new timber roof supported on a series of steel beams from the flat roof deck. All concrete sections sounded appeared to be solid with no hollow elements noted and no indentations made in the concrete.
Area 2 inspected	Ground floor store areas and the upper floor construction for the first-floor flats.
Methods used for area 2	Visual inspection of store areas.

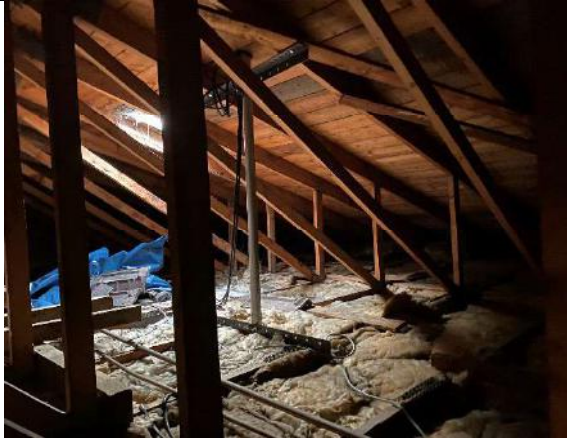
Conclusions for area 1	Timber rafters, timber struts and timber ceiling ties are noted to the mono pitched roof sections of the block. This confirms the use of structural timbers forming the main roof structure. Flat roof section above common close section with plaster finish also noted as timber joists.
Area 2 inspected	Inner leaf of wall construction is visible from within attic space of pitched roof section.
Methods used for area 2	Visual inspection of brick in attic space
Evidence gathered for area 2

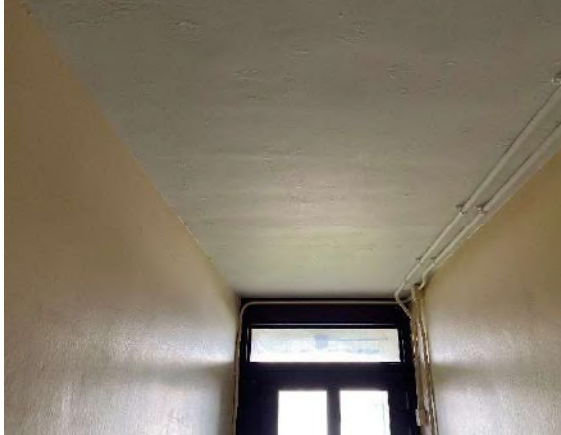
Conclusions for area 2	Solid concrete slabs noted throughout, precast stairs also note.

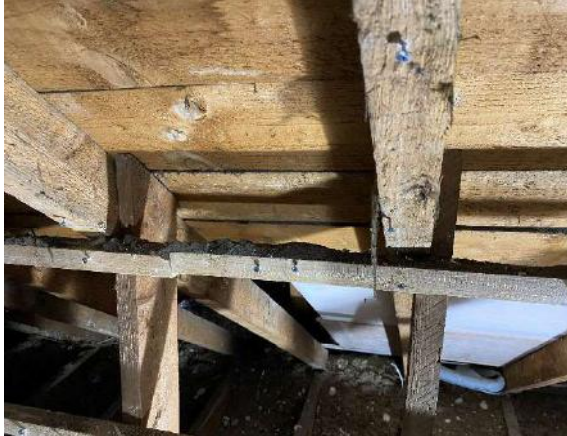
Conclusions for area 1	Timber rafters, timber struts and timber ceiling ties are noted to the duo pitched roof of the block. This confirms the use of structural timbers forming the main roof structure.
Area 2 inspected	External rear render section of wall construction is visible from ground level.
Methods used for area 2	Visual inspection of external wall construction
Evidence gathered for area 2

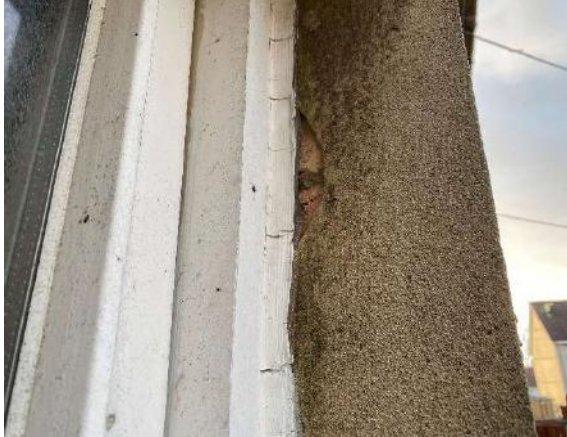
Conclusions for area 2	Clay brick is present below the render finish. A RAAC panel is not present.

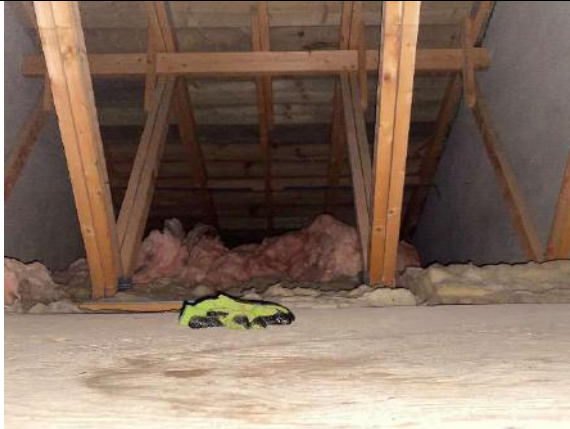
Conclusions for area 1	Fink Timber trusses are noted to the duo pitched roof sections of the block. This confirms the use of structural timbers forming the main roof structure.
Area 2 inspected	Common close to all floors.
Methods used for area 2	Hammer testing of all concrete elements.
Evidence gathered for area 2

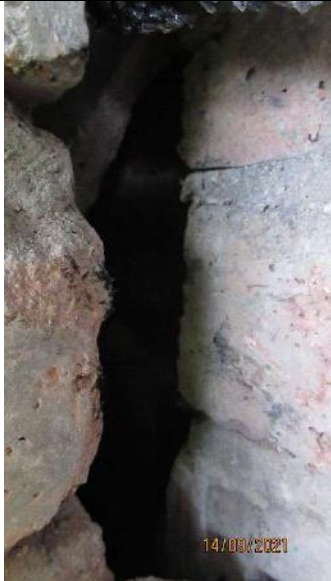
Conclusions for area 1	Front and side walls of the property have a mixture of rendered brick and exposed brick. These areas were opened up to confirm the existence of cavity brick.
Area 2 inspected	Concrete perimeter beams to the block.
Methods used for area 2	Review of cracked sections of concrete prior to repair to confirm concrete type.
Evidence gathered for area 2

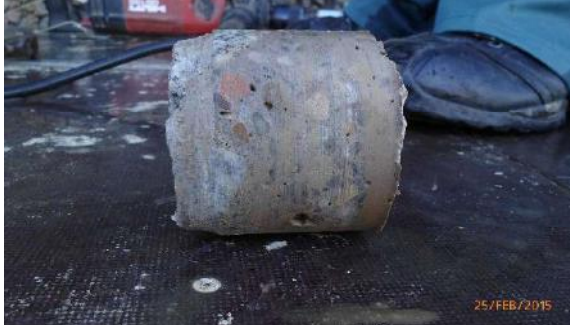
Conclusions for area 1	Precast concrete panels were noted and the core sample confirmed a precast concrete panel arrangement with solid concrete suitable for receiving an EWl system.
Area 2 inspected	Ceiling of upper landing area inspected to underside of roof and found to have a solid concrete finish.
Methods used for area 2	Access was gained to the common close at top floor level
Evidence gathered for area 2

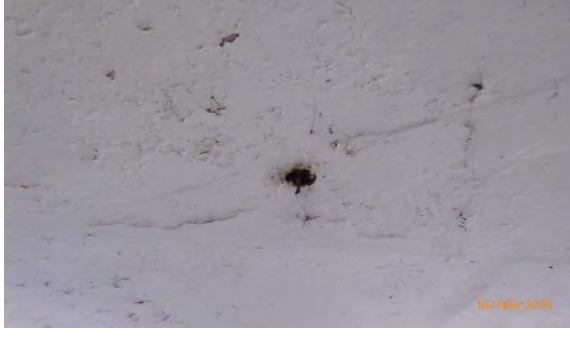
Conclusions for area 2	The former flat roof section above common close section is noted as an RC slab. Hammer testing to the ceiling below confirmed a solid RC slab, with no hollow sections and a solid "ping" produced. No indentations were made in the slab either. Historic drawings confirmed a 4 1/2" concrete roof.

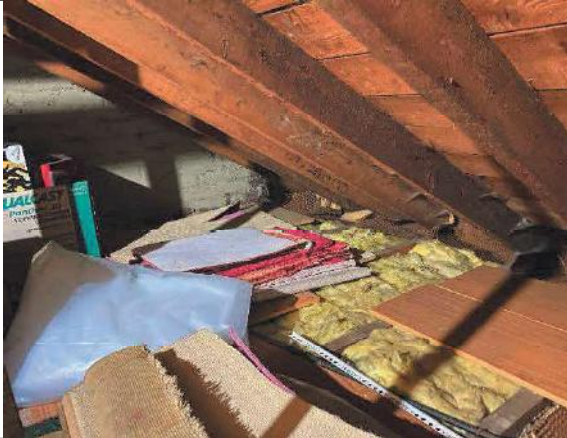
Conclusions for area 1	Timber trusses and timber ceiling ties are noted to the duo pitched roof. This confirms the use of structural timbers forming the main roof structure.
Area 2 inspected	Inner leaf of wall construction is visible from within attic space duo pitched roof section.
Methods used for area 2	Visual inspection of brick in attic space
Evidence gathered for area 2

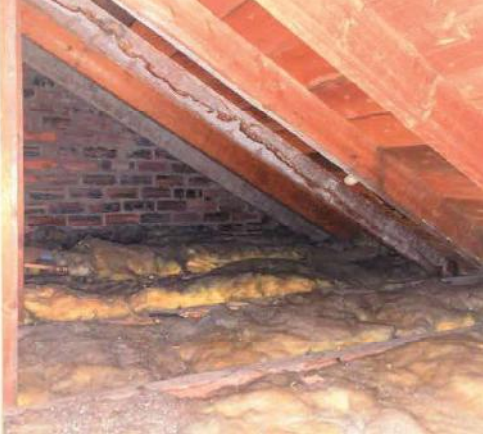
Conclusions for area 1	Timber trusses and timber ceiling ties are noted to the duo pitched roof. This confirms the use of structural timbers forming the main roof structure.
Area 2 inspected	Inner leaf of wall construction is visible from within attic space duo pitched roof section.
Methods used for area 2	Visual inspection of brick in attic space
Evidence gathered for area 2

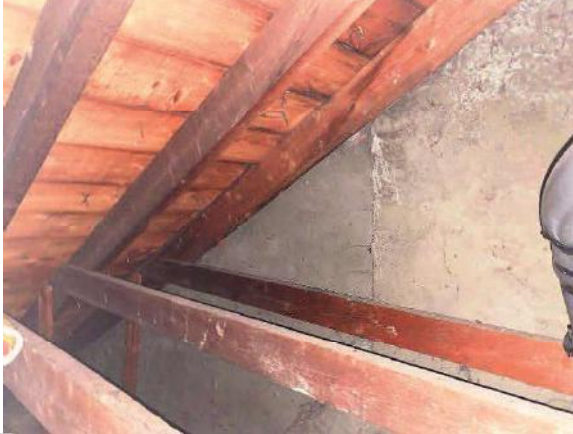
Conclusions for area 1	Timber trusses and timber ceiling ties are noted to the duo pitched roof. This confirms the use of structural timbers forming the main roof structure.
Area 2 inspected	Inner leaf of wall construction is visible from within attic space duo pitched roof section.
Methods used for area 2	Visual inspection of brick in attic space
Evidence gathered for area 2

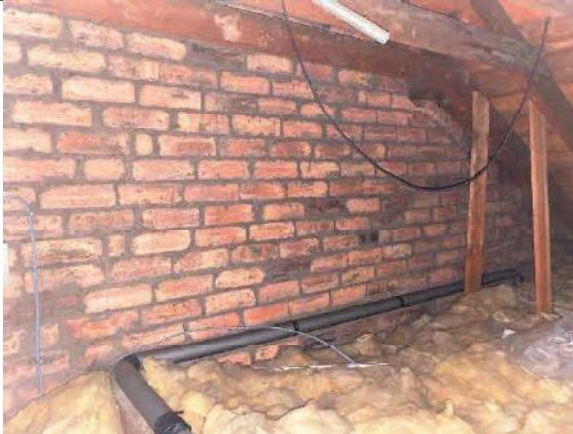
Conclusions for area 2	Clay brick is present as the inner leaf of the main wall construction. RAAC panels are not present.

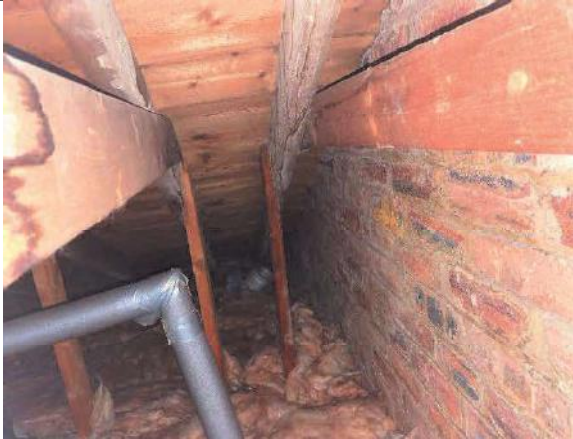
Conclusions for area 2	Clay brick is present as the inner leaf of the main wall construction. RAAC panels are not present.

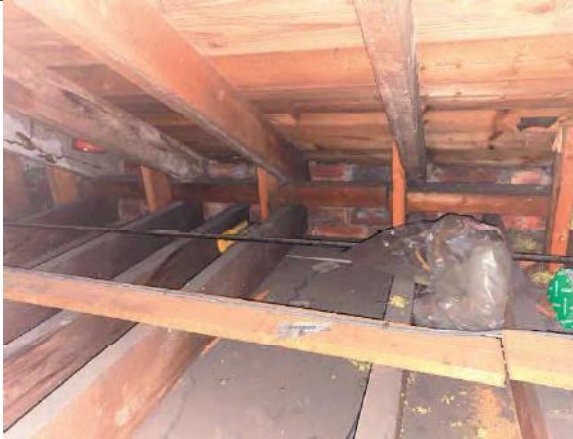
Conclusions for area 2	Clay brick is present as the inner leaf of the main wall construction. RAAC panels are not present.

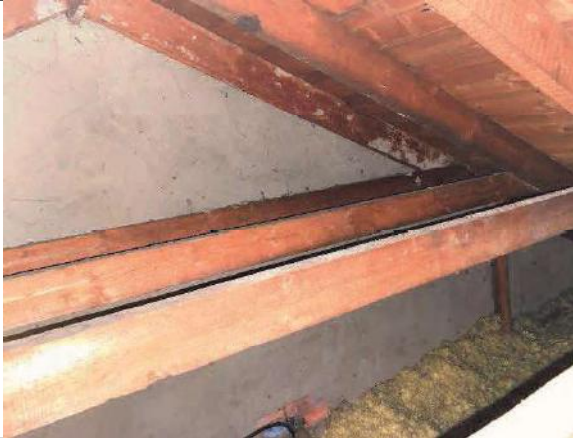
Conclusions for area 1	Timber trusses and timber ceiling ties are noted to the duo pitched roof. This confirms the use of structural timbers forming the main roof structure.
Area 2 inspected	Inner leaf of wall construction is visible from within attic space duo pitched roof section.
Methods used for area 2	Visual inspection of brick in attic space
Evidence gathered for area 2

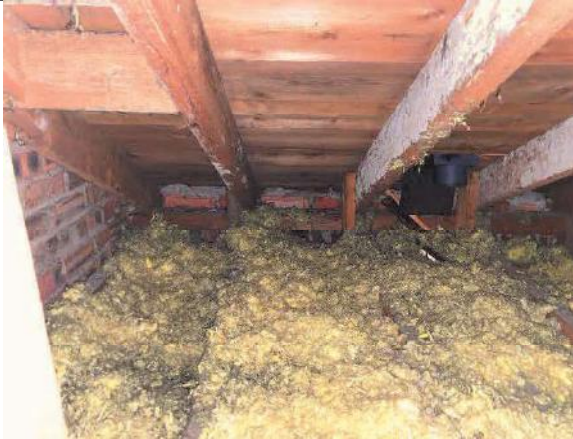
Conclusions for area 2	Clay brick is present as the inner leaf of the main wall construction. RAAC panels are not present.

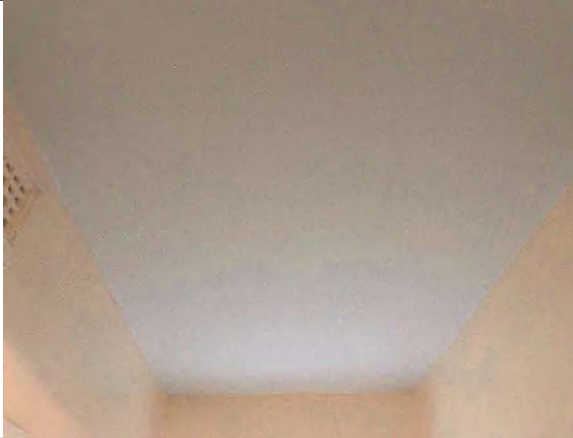
Area 1 inspected	Ceiling of upper landing area inspected to underside of roof and found to have a finished board material to the ceiling.
Methods used for area 1	Access was gained to the attic space of pitched roof section from the common close at top floor level
Evidence gathered for area 1

Conclusions for area 1	Timber trusses and timber ceiling ties are noted to the duo pitched roof. This confirms the use of structural timbers forming the main roof structure.
Area 2 inspected	Inner leaf of wall construction is visible from within attic space duo pitched roof section.
Methods used for area 2	Visual inspection of brick in attic space
Evidence gathered for area 2

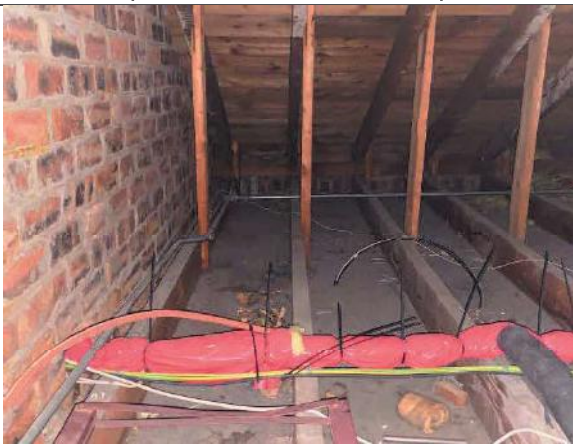
Conclusions for area 2	Clay brick is present as the inner leaf of the main wall construction. RAAC panels are not present.

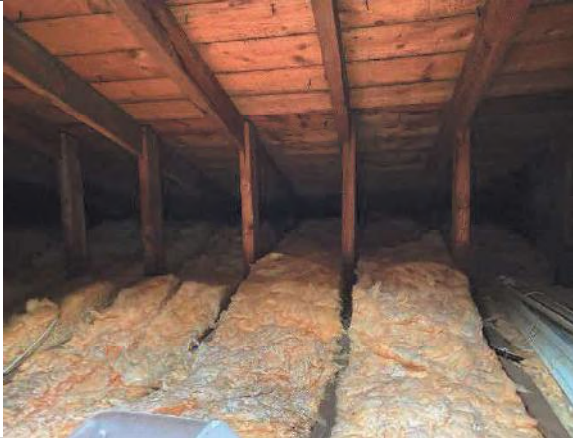
Area 1 inspected	Ceiling of upper floor area inspected to underside of roof and found to have a finished board material to the ceiling.
Methods used for area 1	Access was gained to the attic space of pitched roof section from the hall at top floor level
Evidence gathered for area 1

Conclusions for area 1	Timber trusses and timber ceiling ties are noted to the duo pitched roof. This confirms the use of structural timbers forming the main roof structure.
Area 2 inspected	Inner leaf of wall construction is visible from within attic space duo pitched roof section.
Methods used for area 2	Visual inspection of brick in attic space
Evidence gathered for area 2

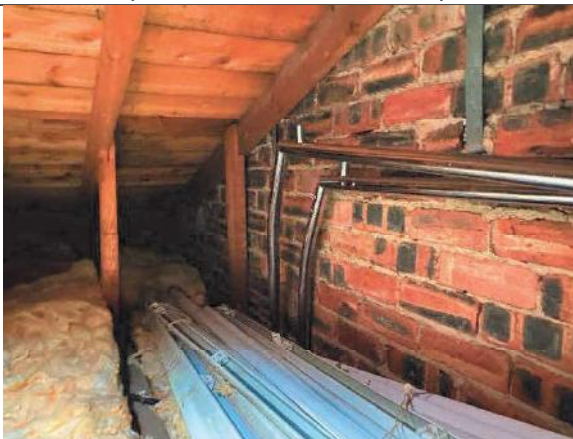
Conclusions for area 2	Clay brick is present as the inner leaf of the main wall construction. RAAC panels are not present.

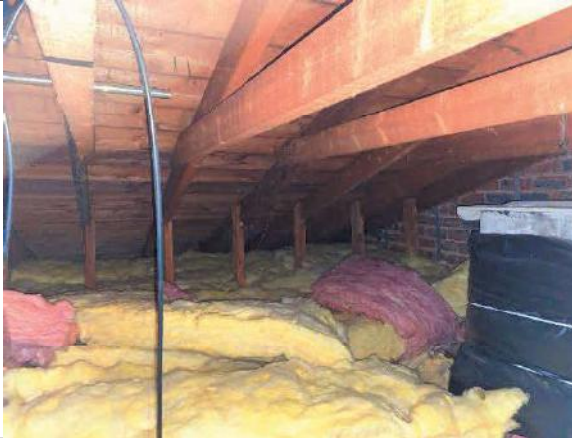
Area 1 inspected	Ceiling of upper floor area inspected to underside of roof and found to have a finished board material to the ceiling.
Methods used for area 1	Access was gained to the attic space of pitched roof section from the hall at top floor level
Evidence gathered for area 1

Conclusions for area 1	Timber trusses and timber ceiling ties are noted to the duo pitched roof. This confirms the use of structural timbers forming the main roof structure.
Area 2 inspected	Inner leaf of wall construction is visible from within attic space duo pitched roof section.
Methods used for area 2	Visual inspection of brick in attic space
Evidence gathered for area 2

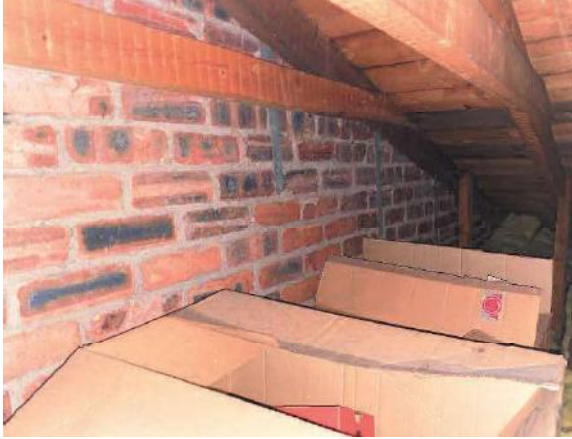
Conclusions for area 2	Clay brick is present as the inner leaf of the main wall construction. RAAC panels are not present.

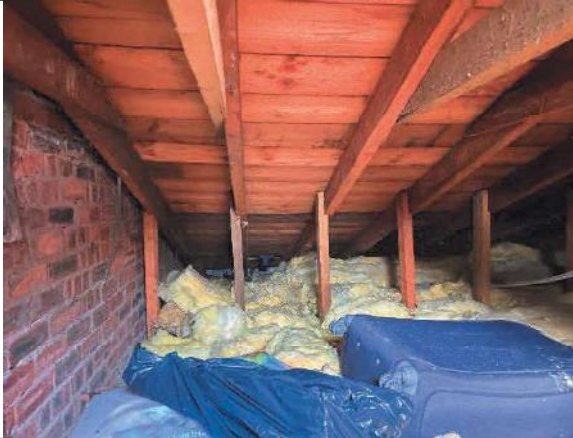
Area 1 inspected	Ceiling of upper floor area inspected to underside of roof and found to have a finished board material to the ceiling.
Methods used for area 1	Access was gained to the attic space of pitched roof section from the hall at top floor level
Evidence gathered for area 1

Conclusions for area 1	Timber trusses and timber ceiling ties are noted to the duo pitched roof. This confirms the use of structural timbers forming the main roof structure.
Area 2 inspected	Inner leaf of wall construction is visible from within attic space duo pitched roof section.
Methods used for area 2	Visual inspection of brick in attic space
Evidence gathered for area 2

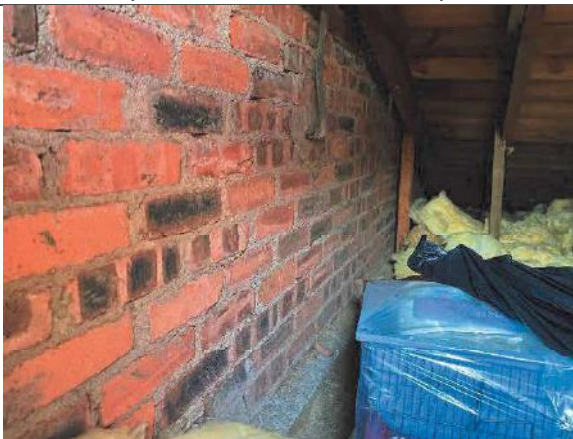
Conclusions for area 2	Clay brick is present as the inner leaf of the main wall construction. RAAC panels are not present.

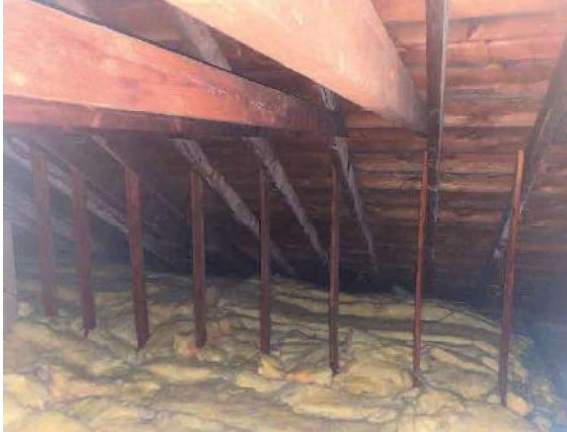
Area 1 inspected	Ceiling of upper landing area inspected to underside of roof and found to have a reinforced concrete slab finish.
Methods used for area 1	Access was gained to the attic space of pitched roof section from the common close at top floor level. A series of reinforced concrete beams have been used above the common close area. Standard ceiling ties above flats.
Evidence gathered for area 1

Conclusions for area 1	Timber trusses and timber ceiling ties are noted to the duo pitched roof. This confirms the use of structural timbers forming the main roof structure.
Area 2 inspected	Inner leaf of wall construction is visible from within attic space duo pitched roof section.
Methods used for area 2	Visual inspection of brick in attic space
Evidence gathered for area 2

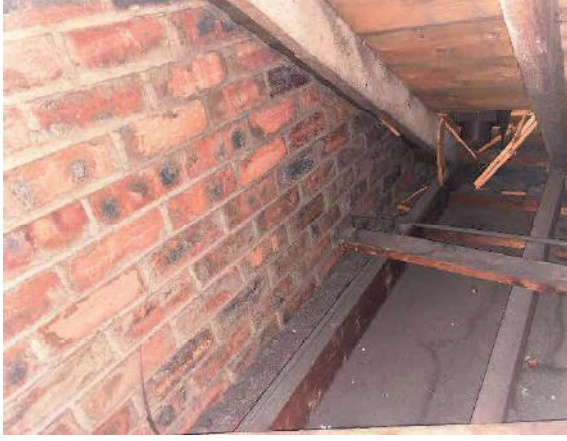
Conclusions for area 2	Clay brick is present as the inner leaf of the main wall construction. RAAC panels are not present.

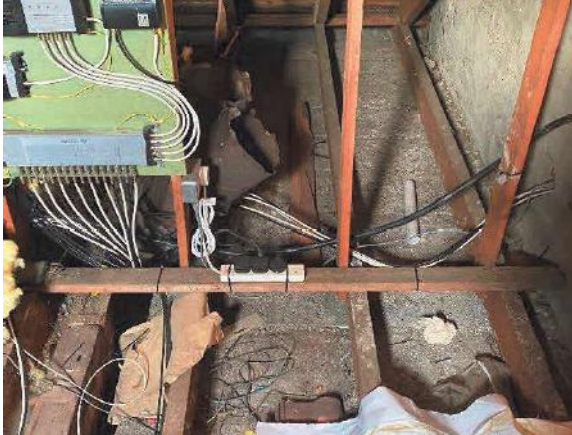
Area 1 inspected	Ceiling of upper landing area inspected to underside of roof and found to have a reinforced concrete slab finish.
Methods used for area 1	Access was gained to the attic space of pitched roof section from the common close at top floor level. A series of reinforced concrete beams have been used above the common close area. Standard ceiling ties above flats.
Evidence gathered for area 1

Conclusions for area 1	Timber trusses and timber ceiling ties are noted to the duo pitched roof. This confirms the use of structural timbers forming the main roof structure.
Area 2 inspected	Inner leaf of wall construction is visible from within attic space duo pitched roof section.
Methods used for area 2	Visual inspection of brick in attic space
Evidence gathered for area 2

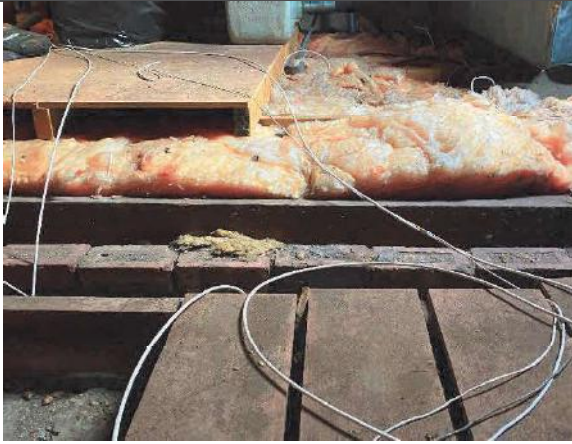
Conclusions for area 2	Clay brick is present as the inner leaf of the main wall construction. RAAC panels are not present.

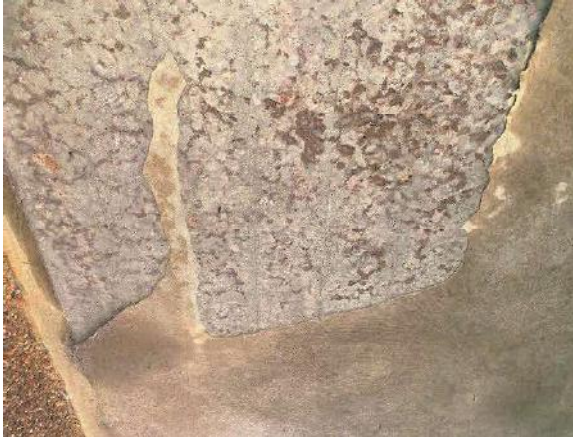
Methods used for area 3	Visual inspection of the underside of the canopy slab
Evidence gathered for area 3

Conclusions for area 3	Precast beams in slab present. Solid “ping” and no indentations were made when pressure applied. No RAAC present.

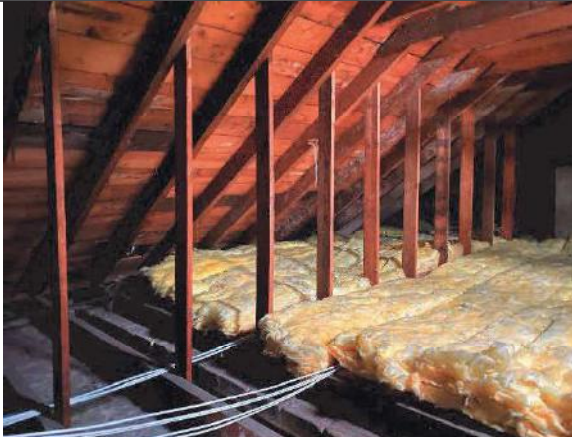
Area 1 inspected	Ceiling of upper landing area inspected to underside of roof and found to have a reinforced concrete slab finish.
Methods used for area 1	Access was gained to the attic space of pitched roof section from the common close at top floor level. A series of reinforced concrete beams have been used above the common close area. Standard ceiling ties above flats.
Evidence gathered for area 1

Conclusions for area 1	Timber trusses and timber ceiling ties are noted to the duo pitched roof. This confirms the use of structural timbers forming the main roof structure.
Area 2 inspected	Inner leaf of wall construction is visible from within attic space duo pitched roof section.
Methods used for area 2	Visual inspection of brick in attic space
Evidence gathered for area 2

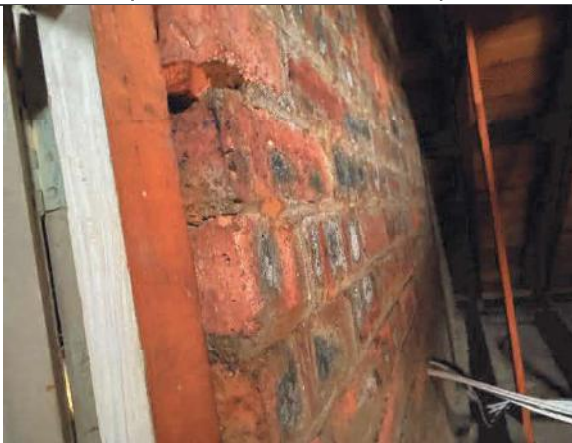
Conclusions for area 2	Clay brick is present as the inner leaf of the main wall construction. RAAC panels are not present.

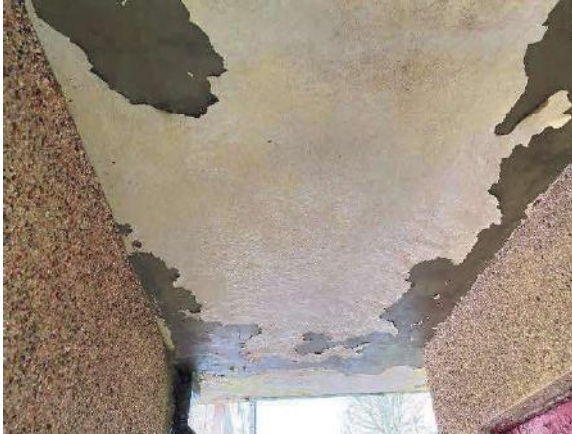
Methods used for area 3	Visual inspection of the underside of the canopy slab
Evidence gathered for area 3

A photograph showing the underside of a concrete canopy slab. The surface is a light, mottled grey color with some darker, irregular patches. A window is visible in the lower center of the frame, showing a view of trees and a sky. The overall appearance is that of a solid, textured concrete surface.
Conclusions for area 3	Reinforced concrete slab present. Solid "ping" and no indentations were made when pressure applied. No RAAC present.

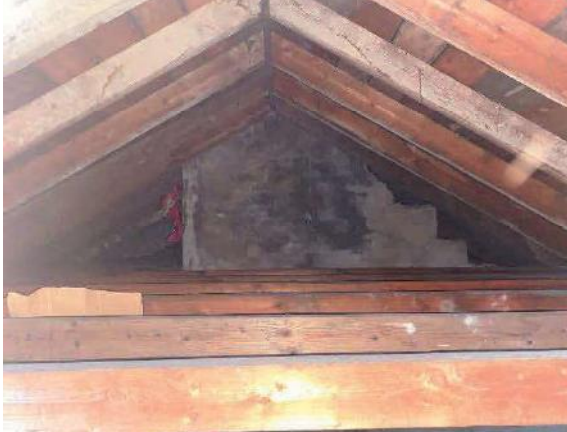
Area 1 inspected	Ceiling of upper landing area inspected to underside of roof and found to have a reinforced concrete slab finish.
Methods used for area 1	Access was gained to the attic space of pitched roof section from the common close at top floor level. A series of reinforced concrete beams have been used above the common close area. Standard ceiling ties above flats.
Evidence gathered for area 1

Conclusions for area 1	Timber trusses and timber ceiling ties are noted to the duo pitched roof. This confirms the use of structural timbers forming the main roof structure.
Area 2 inspected	Inner leaf of wall construction is visible from within attic space duo pitched roof section.
Methods used for area 2	Visual inspection of brick in attic space
Evidence gathered for area 2

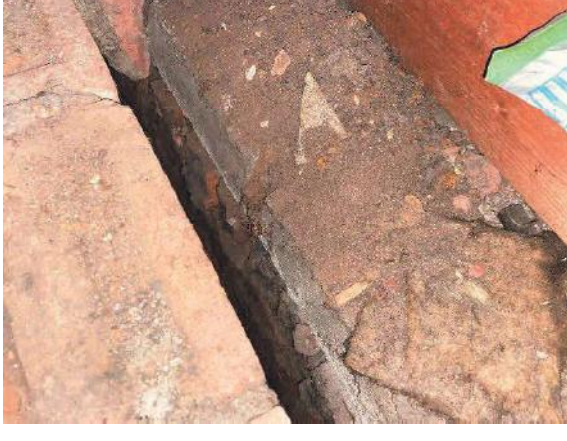
Conclusions for area 2	Clay brick is present as the inner leaf of the main wall construction. RAAC panels are not present.

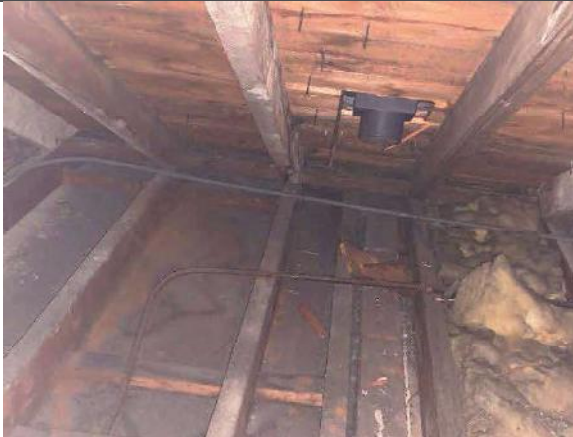
Area 1 inspected	Ceiling of upper landing area inspected to underside of roof and found to have a reinforced concrete slab finish.
Methods used for area 1	Access was gained to the attic space of pitched roof section from the common close at top floor level. A series of reinforced concrete beams have been used above the common close area. Standard ceiling ties above flats.
Evidence gathered for area 1

Conclusions for area 1	Timber trusses and timber ceiling ties are noted to the duo pitched roof. This confirms the use of structural timbers forming the main roof structure.
Area 2 inspected	Inner leaf of wall construction is visible from within attic space duo pitched roof section.
Methods used for area 2	Visual inspection of brick in attic space
Evidence gathered for area 2

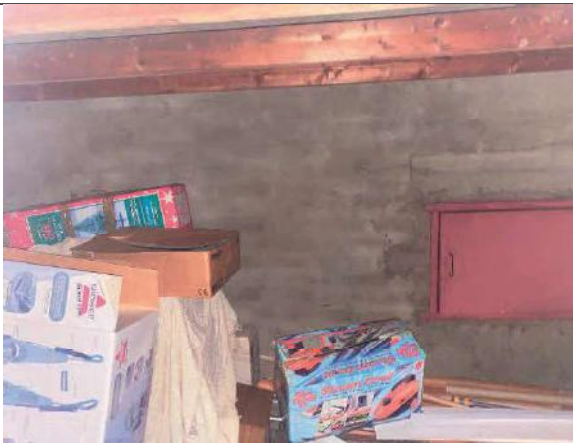
Conclusions for area 2	Clay brick is present as the inner leaf of the main wall construction. RAAC panels are not present.

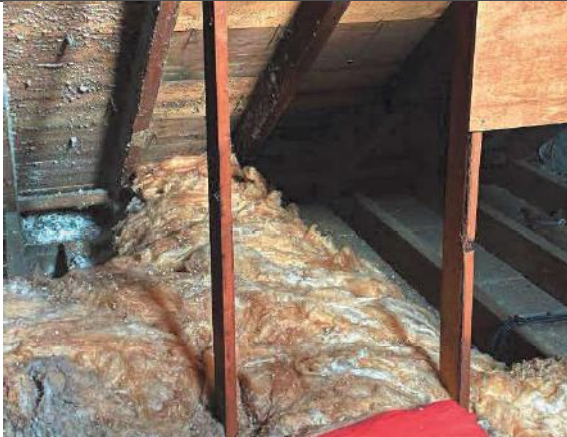
Area 1 inspected	Ceiling of upper landing area inspected to underside of roof and found to have a reinforced concrete slab finish.
Methods used for area 1	Access was gained to the attic space of pitched roof section from the common close at top floor level. A series of reinforced concrete beams have been used above the common close area. Standard ceiling ties above flats.
Evidence gathered for area 1

Conclusions for area 1	Timber trusses and timber ceiling ties are noted to the duo pitched roof. This confirms the use of structural timbers forming the main roof structure.
Area 2 inspected	Inner leaf of wall construction is visible from within attic space duo pitched roof section.
Methods used for area 2	Visual inspection of brick in attic space
Evidence gathered for area 2

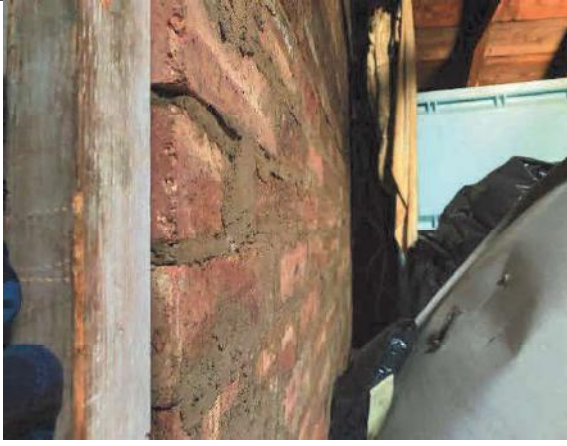
Conclusions for area 2	Clay brick is present as the inner leaf of the main wall construction. RAAC panels are not present.

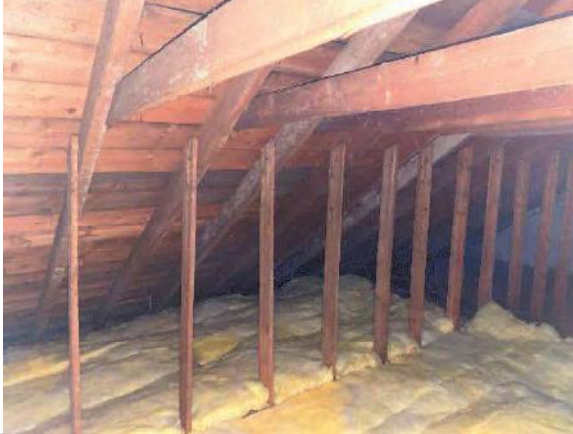
Area 1 inspected	Ceiling of upper landing area inspected to underside of roof and found to have a finished board material to the ceiling.
Methods used for area 1	Access was gained to the attic space of pitched roof section from the common close at top floor level
Evidence gathered for area 1

Conclusions for area 1	Timber trusses and timber ceiling ties are noted to the duo pitched roof. This confirms the use of structural timbers forming the main roof structure.
Area 2 inspected	Inner leaf of wall construction is visible from within attic space duo pitched roof section.
Methods used for area 2	Visual inspection of brick in attic space
Evidence gathered for area 2

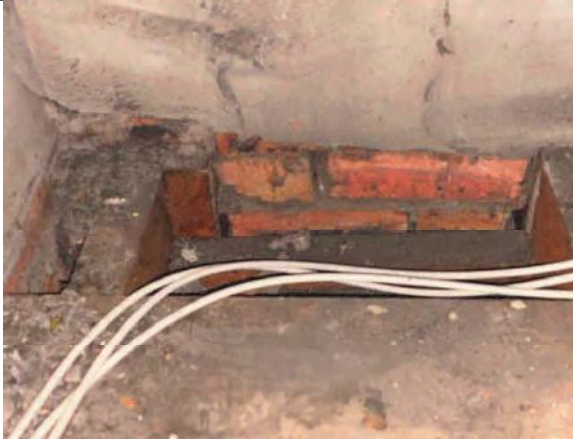
Conclusions for area 2	Clay brick is present as the inner leaf of the main wall construction. RAAC panels are not present.

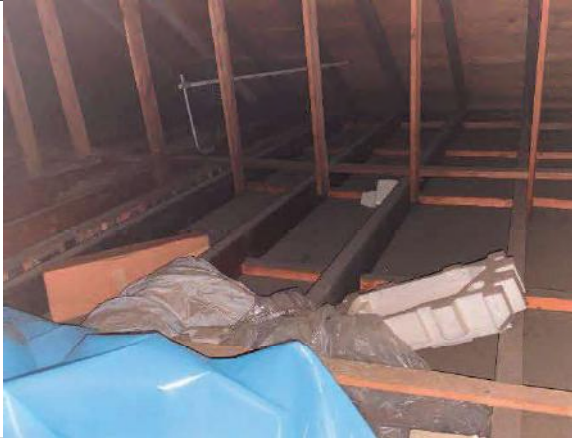
Area 1 inspected	Ceiling of upper landing area inspected to underside of roof and found to have a finished board material to the ceiling.
Methods used for area 1	Access was gained to the attic space of pitched roof section from the common close at top floor level
Evidence gathered for area 1

Conclusions for area 1	Timber trusses and timber ceiling ties are noted to the duo pitched roof. This confirms the use of structural timbers forming the main roof structure.
Area 2 inspected	Inner leaf of wall construction is visible from within attic space duo pitched roof section.
Methods used for area 2	Visual inspection of brick in attic space
Evidence gathered for area 2

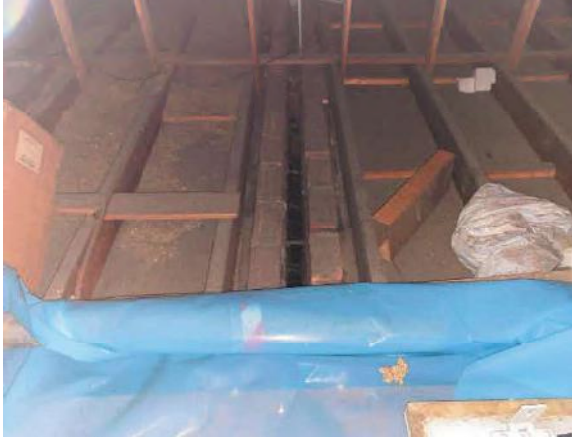
Conclusions for area 2	Clay brick is present as the inner leaf of the main wall construction. RAAC panels are not present.

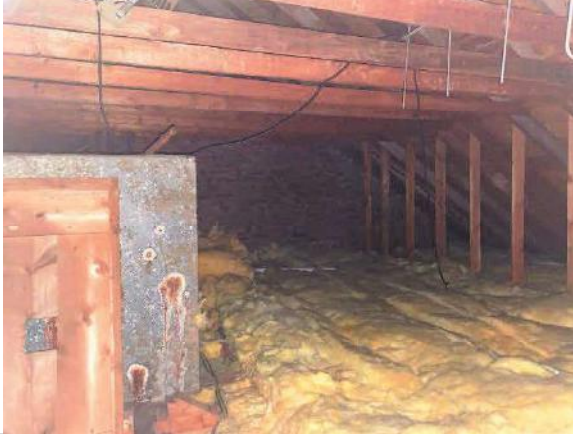
Area 1 inspected	Ceiling of upper landing area inspected to underside of roof and found to have a finished board material to the ceiling.
Methods used for area 1	Access was gained to the attic space of pitched roof section from the common close at top floor level
Evidence gathered for area 1

Conclusions for area 1	Timber trusses and timber ceiling ties are noted to the duo pitched roof. This confirms the use of structural timbers forming the main roof structure.
Area 2 inspected	Inner leaf of wall construction is visible from within attic space duo pitched roof section.
Methods used for area 2	Visual inspection of brick in attic space
Evidence gathered for area 2

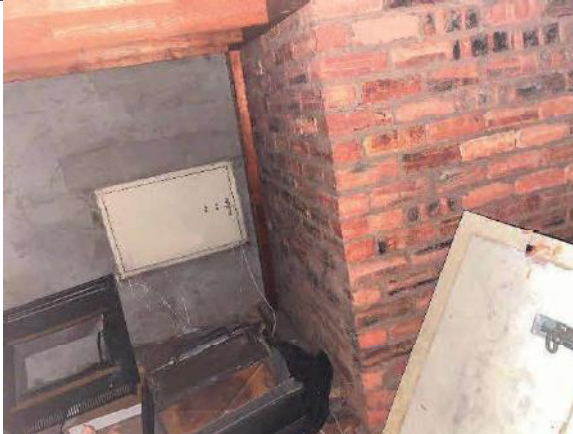
Conclusions for area 2	Clay brick is present as the inner leaf of the main wall construction. RAAC panels are not present.
Area 3 inspected	External concrete canopies at front and rear entrances
Methods used for area 3	Visual inspection and hammer test of the soffit of the canopies.

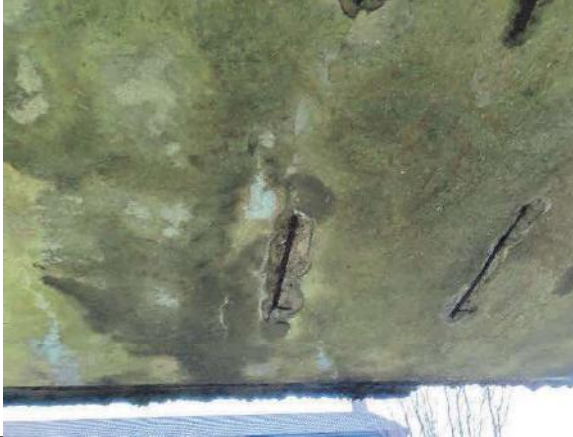
A photograph showing a close-up view of a concrete slab. The surface is dark and appears to be a mix of green and grey, possibly due to algae or weathering. There are several dark, vertical lines protruding from the surface, which are reinforcement bars (rebar). The concrete around these bars shows signs of spalling and cracking.
Conclusions for area 3	Reinforcement in RC slabs noted in the canopy where spalling has occurred, solid ping and no indentations noted. No RAAC concrete in the canopies.

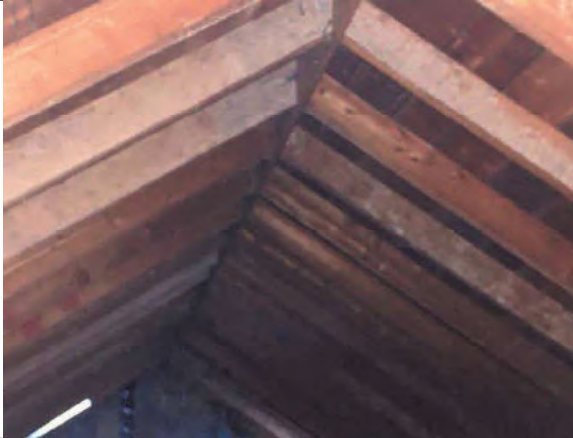
Area 1 inspected	Ceiling of upper landing area inspected to underside of roof and found to have a finished board material to the ceiling.
Methods used for area 1	Access was gained to the attic space of pitched roof section from the common close at top floor level
Evidence gathered for area 1

Conclusions for area 1	Timber trusses and timber ceiling ties are noted to the duo pitched roof. This confirms the use of structural timbers forming the main roof structure.
Area 2 inspected	Inner leaf of wall construction is visible from within attic space duo pitched roof section.
Methods used for area 2	Visual inspection of brick in attic space
Evidence gathered for area 2

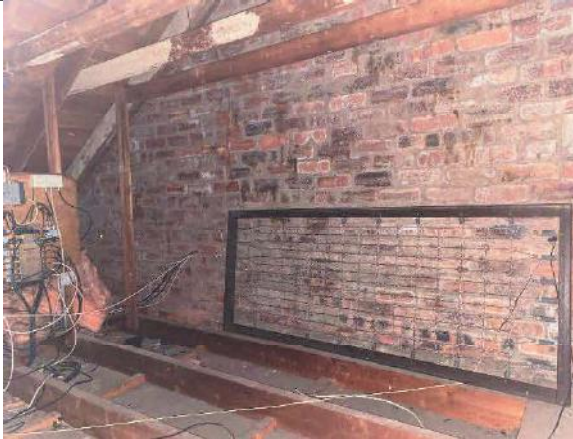
Conclusions for area 2	Clay brick is present as the inner leaf of the main wall construction. RAAC panels are not present.

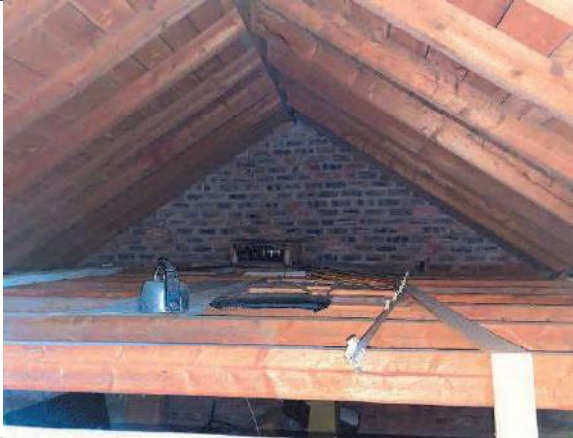
Area 1 inspected	Ceiling of upper landing area inspected to underside of roof and found to have a finished board material to the ceiling.
Methods used for area 1	Access was gained to the attic space of pitched roof section from the common close at top floor level
Evidence gathered for area 1

A photograph showing the interior of an attic space. The view is looking up at a series of wooden trusses that form a pitched roof. The trusses are made of light-colored wood and are connected by horizontal ties. The ceiling is made of dark wood. In the background, a brick wall is visible. A blue object, possibly a tool or container, is on the floor of the attic.
Conclusions for area 1	Timber trusses and timber ceiling ties are noted to the duo pitched roof. This confirms the use of structural timbers forming the main roof structure.
Area 2 inspected	Inner leaf of wall construction is visible from within attic space duo pitched roof section.

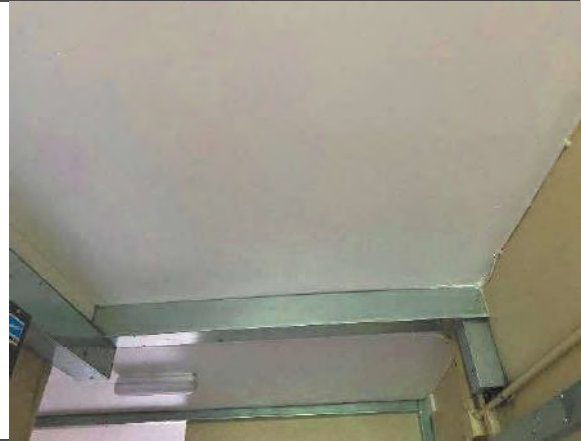
Conclusions for area 3

Precast concrete beams noted, hammer test confirmed a solid ping with no indentations made while inspecting. No RAAC concrete present.

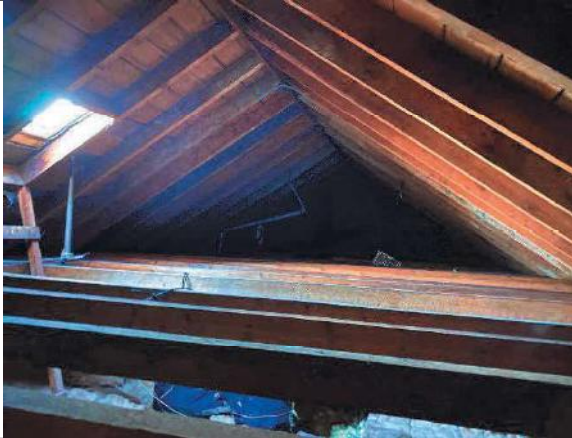
Area 1 inspected	Ceiling of upper landing area inspected to underside of roof and found to have a finished board material to the ceiling.
Methods used for area 1	Access was gained to the attic space of pitched roof section from the common close at top floor level
Evidence gathered for area 1

Conclusions for area 1	Timber trusses and timber ceiling ties are noted to the duo pitched roof. This confirms the use of structural timbers forming the main roof structure.
Area 2 inspected	Inner leaf of wall construction is visible from within attic space duo pitched roof section.
Methods used for area 2	Visual inspection of brick in attic space
Evidence gathered for area 2

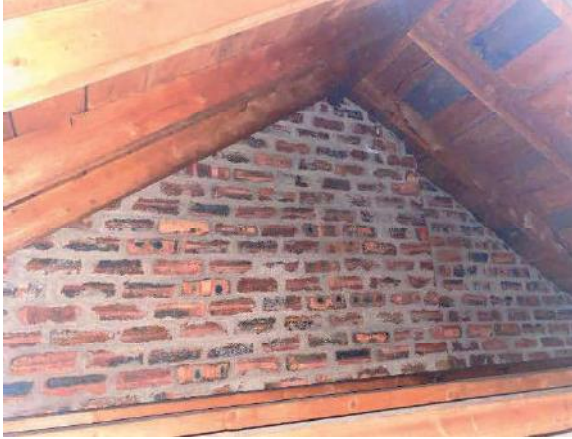
Conclusions for area 2	Clay brick is present as the inner leaf of the main wall construction. RAAC panels are not present.

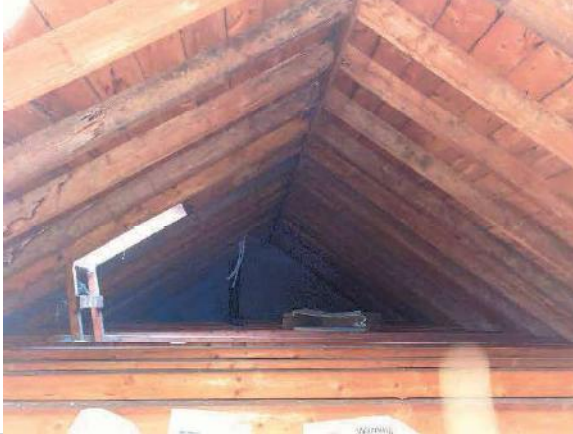
Area 1 inspected	Ceiling of upper landing area inspected to underside of roof and found to have a finished board material to the ceiling.
Methods used for area 1	Access was gained to the attic space of pitched roof section from the common close at top floor level
Evidence gathered for area 1

Conclusions for area 1	Timber trusses and timber ceiling ties are noted to the duo pitched roof. This confirms the use of structural timbers forming the main roof structure.
Area 2 inspected	Inner leaf of wall construction is visible from within attic space duo pitched roof section.
Methods used for area 2	Visual inspection of brick in attic space
Evidence gathered for area 2

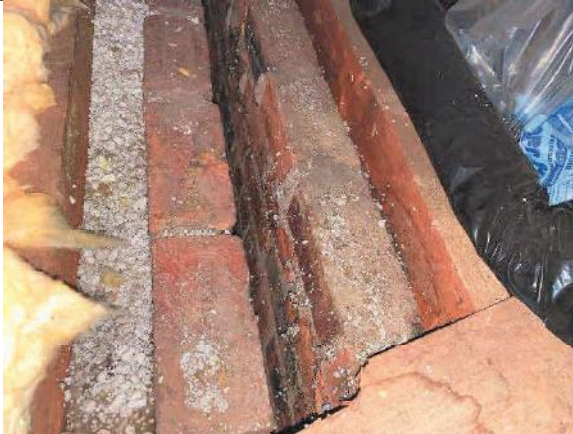
Conclusions for area 2	Clay brick is present as the inner leaf of the main wall construction. RAAC panels are not present.
Area 3 inspected	Rear single storey flat roof section at bin stores and storerooms
Methods used for area 3	Visual inspection of underside of the flat concrete roof slab

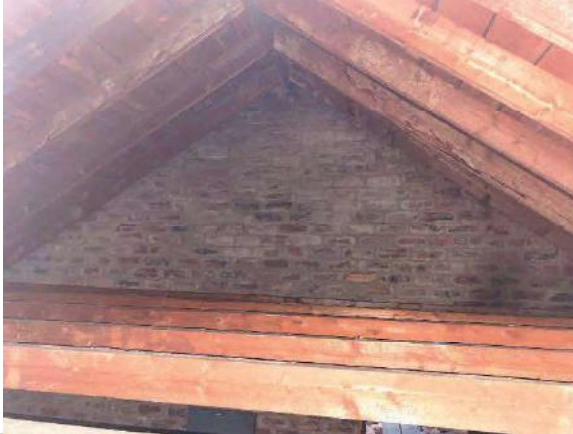
Area 1 inspected	Ceiling of upper landing area inspected to underside of roof and found to have a finished board material to the ceiling.
Methods used for area 1	Access was gained to the attic space of pitched roof section from the common close at top floor level
Evidence gathered for area 1

Conclusions for area 1	Timber trusses and timber ceiling ties are noted to the duo pitched roof. This confirms the use of structural timbers forming the main roof structure.
Area 2 inspected	Inner leaf of wall construction is visible from within attic space duo pitched roof section.
Methods used for area 2	Visual inspection of brick in attic space
Evidence gathered for area 2

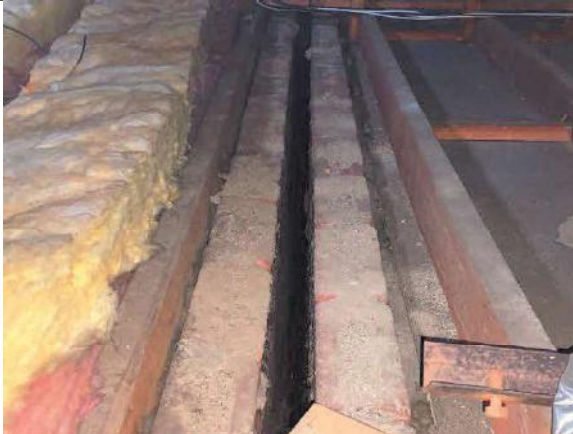
Conclusions for area 2	Clay brick is present as the inner leaf of the main wall construction. RAAC panels are not present.
Area 3 inspected	Rear single storey flat roof section at bin stores and storerooms
Methods used for area 3	Visual inspection of underside of the flat concrete roof slab

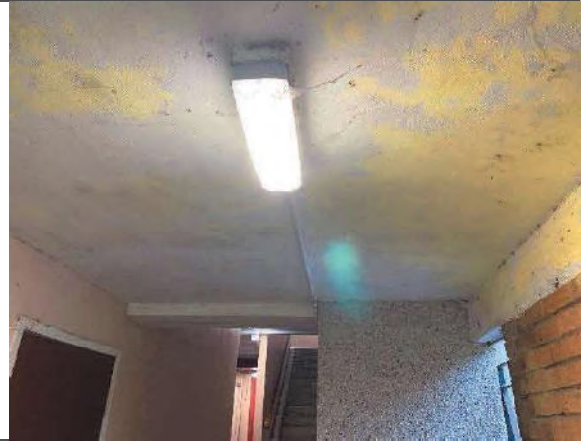
Evidence gathered for area 3

Reinforced concrete slab noted, hammer test confirmed a solid ping with no indentations made while inspecting. No RAAC concrete present.

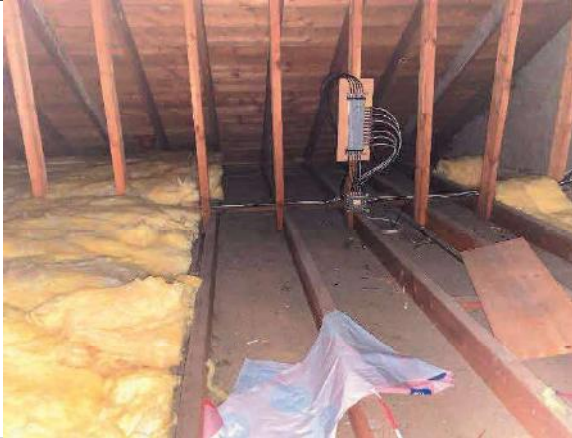
Area 1 inspected	Ceiling of upper landing area inspected to underside of roof and found to have a finished board material to the ceiling.
Methods used for area 1	Access was gained to the attic space of pitched roof section from the common close at top floor level
Evidence gathered for area 1

Conclusions for area 1	Timber trusses and timber ceiling ties are noted to the duo pitched roof. This confirms the use of structural timbers forming the main roof structure.
Area 2 inspected	Inner leaf of wall construction is visible from within attic space duo pitched roof section.
Methods used for area 2	Visual inspection of brick in attic space
Evidence gathered for area 2
