Review of likelihood of RAAC in Wheatley Group Properties

December 2023

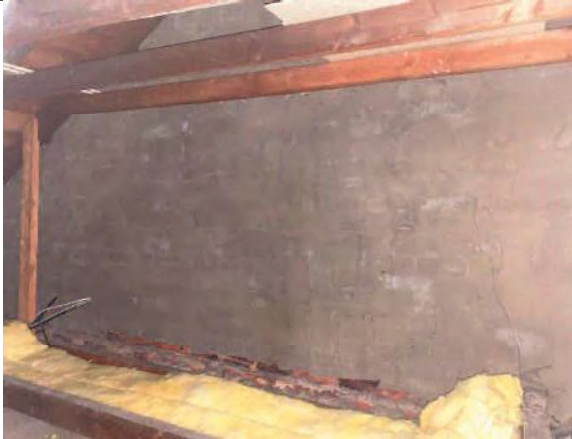
Conclusions for area 2	Clay brick is present as the inner leaf of the main wall construction. RAAC panels are not present.
Area 3 inspected	Rear single storey flat roof section at bin stores and storerooms
Methods used for area 3	Visual inspection of underside of the flat concrete roof slab

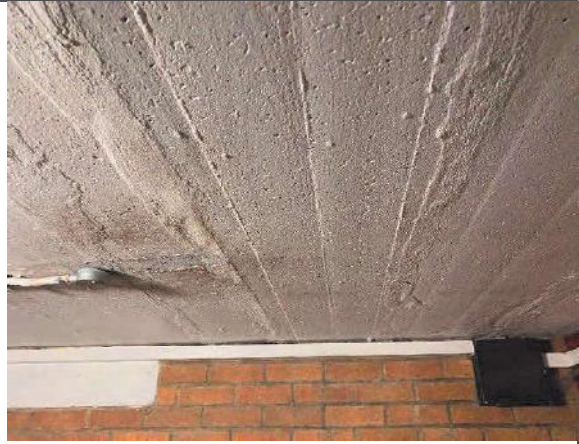
Evidence gathered for area 3

Precast concrete beams noted, hammer test confirmed a solid ping with no indentations made while inspecting. No RAAC concrete present.

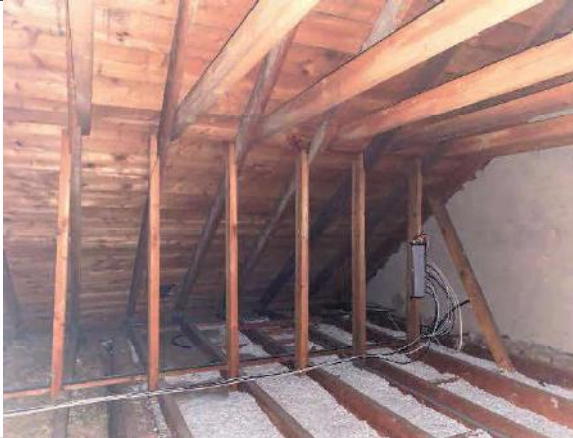
Area 1 inspected	Ceiling of upper landing area inspected to underside of roof and found to have a finished board material to the ceiling.
Methods used for area 1	Access was gained to the attic space of pitched roof section from the common close at top floor level
Evidence gathered for area 1

Conclusions for area 1	Timber trusses and timber ceiling ties are noted to the duo pitched roof. This confirms the use of structural timbers forming the main roof structure.
Area 2 inspected	Inner leaf of wall construction is visible from within attic space duo pitched roof section.
Methods used for area 2	Visual inspection of brick in attic space
Evidence gathered for area 2

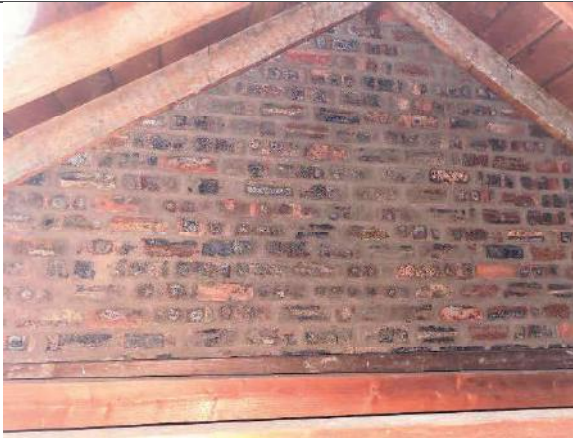
Conclusions for area 2	Clay brick is present as the inner leaf of the main wall construction. RAAC panels are not present.
Area 3 inspected	Rear single storey flat roof section at bin stores and storerooms
Methods used for area 3	Visual inspection of underside of the flat concrete roof slab

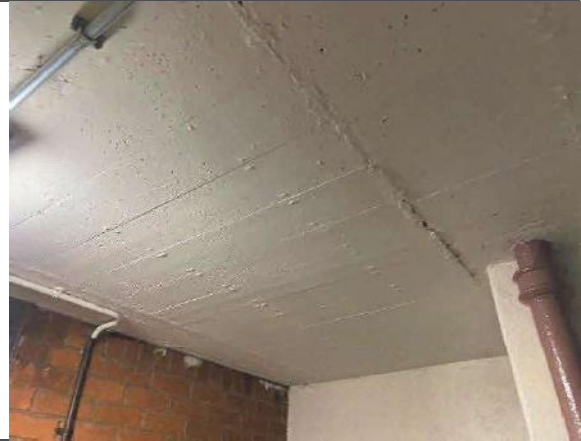
Evidence gathered for area 3

Precast concrete beams noted, hammer test confirmed a solid ping with no indentations made while inspecting. No RAAC concrete present.

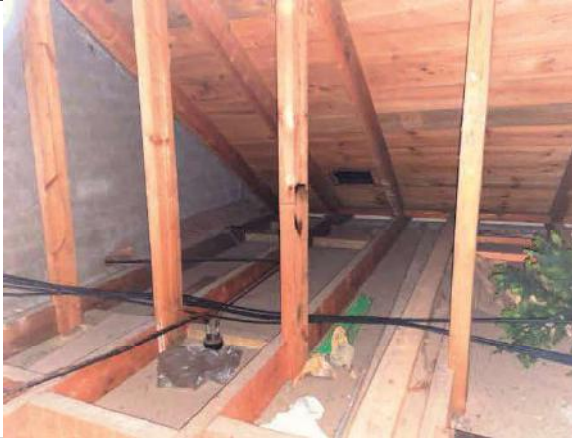
Area 1 inspected	Ceiling of upper landing area inspected to underside of roof and found to have a finished board material to the ceiling.
Methods used for area 1	Access was gained to the attic space of pitched roof section from the common close at top floor level
Evidence gathered for area 1

Conclusions for area 1	Timber trusses and timber ceiling ties are noted to the duo pitched roof. This confirms the use of structural timbers forming the main roof structure.
Area 2 inspected	Inner leaf of wall construction is visible from within attic space duo pitched roof section.
Methods used for area 2	Visual inspection of brick in attic space
Evidence gathered for area 2

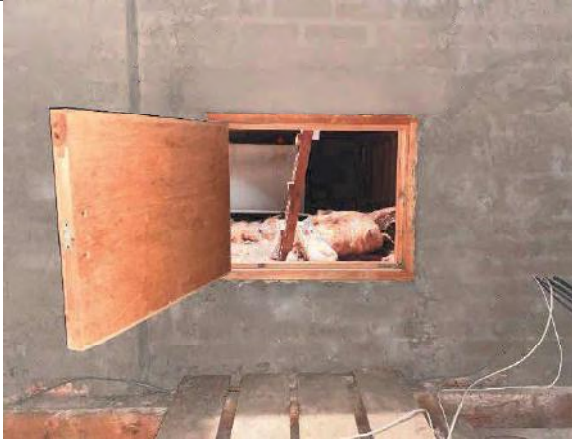
Conclusions for area 2	Clay brick is present as the inner leaf of the main wall construction. RAAC panels are not present.
Area 3 inspected	Rear single storey flat roof section at bin stores and storerooms
Methods used for area 3	Visual inspection of underside of the flat concrete roof slab

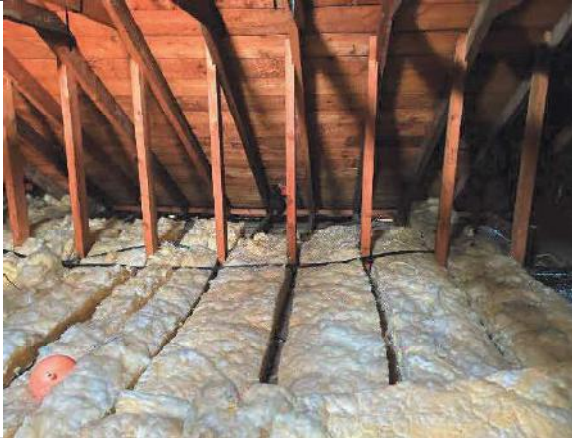
Area 1 inspected	Ceiling of upper landing area inspected to underside of roof and found to have a finished board material to the ceiling.
Methods used for area 1	Access was gained to the attic space of pitched roof section from the common close at top floor level
Evidence gathered for area 1

Conclusions for area 1	Timber trusses and timber ceiling ties are noted to the duo pitched roof. This confirms the use of structural timbers forming the main roof structure.
Area 2 inspected	Inner leaf of wall construction is visible from within attic space duo pitched roof section.
Methods used for area 2	Visual inspection of brick in attic space
Evidence gathered for area 2

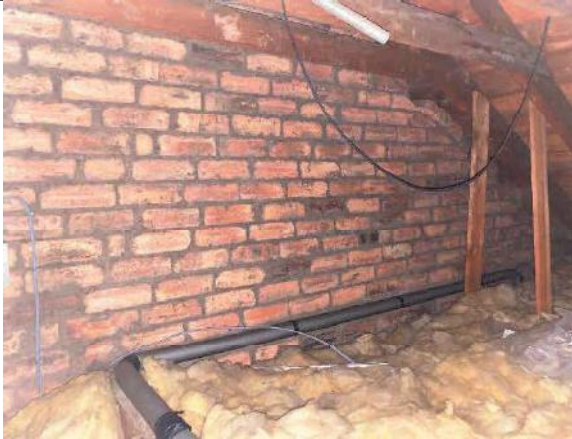
Conclusions for area 2	Clay brick is present as the inner leaf of the main wall construction. RAAC panels are not present.
Area 3 inspected	Rear single storey flat roof section at bin stores and storerooms
Methods used for area 3	Visual inspection of underside of the flat concrete roof slab

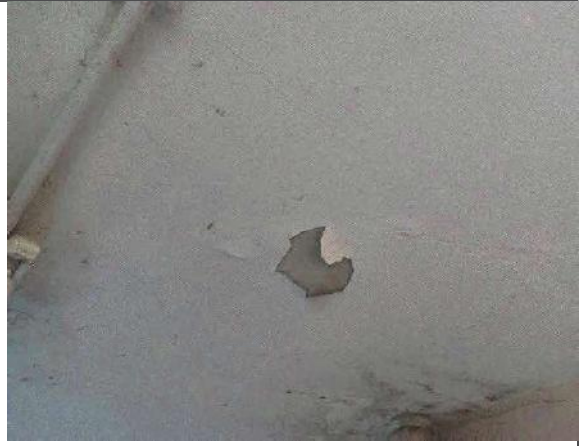
Evidence gathered for area 3

Precast concrete beams noted, hammer test confirmed a solid ping with no indentations made while inspecting. No RAAC concrete present.

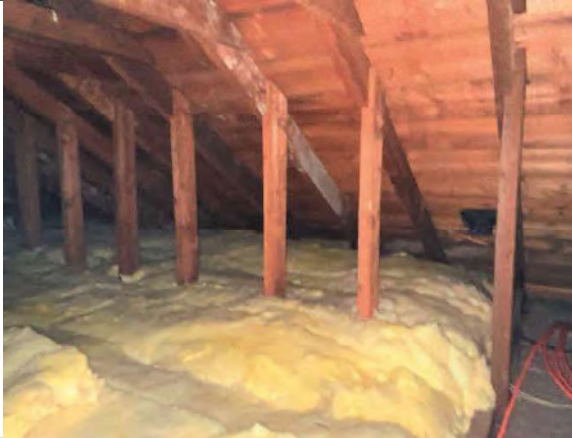
Area 1 inspected	Ceiling of upper landing area inspected to underside of roof and found to have a finished board material to the ceiling.
Methods used for area 1	Access was gained to the attic space of pitched roof section from the common close at top floor level
Evidence gathered for area 1

Conclusions for area 1	Timber trusses and timber ceiling ties are noted to the duo pitched roof. This confirms the use of structural timbers forming the main roof structure.
Area 2 inspected	Inner leaf of wall construction is visible from within attic space duo pitched roof section.
Methods used for area 2	Visual inspection of brick in attic space
Evidence gathered for area 2

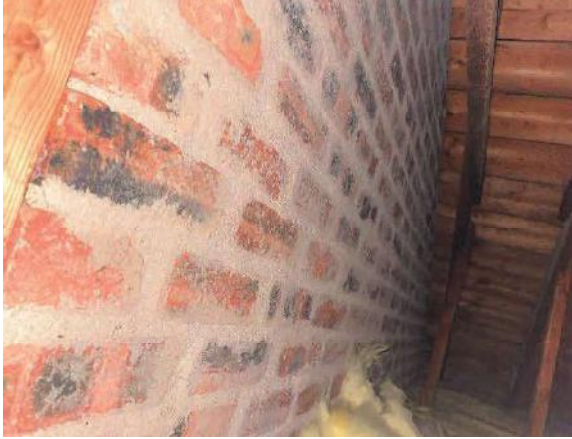
Conclusions for area 2	Clay brick is present as the inner leaf of the main wall construction. RAAC panels are not present.

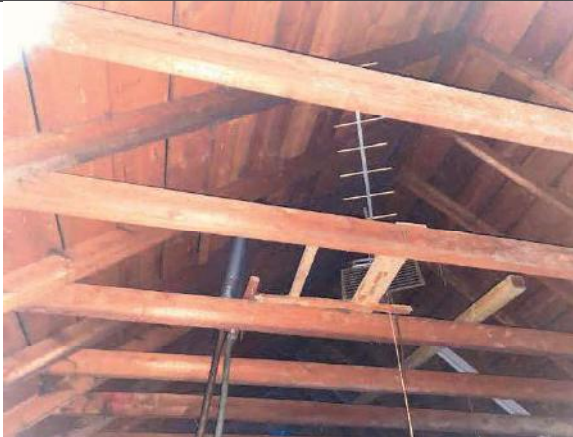
Conclusions for area 1	Timber rafters, timber struts and timber ceiling ties are noted to the duo pitched roof of the block. This confirms the use of structural timbers forming the main roof structure.
Area 2 inspected	Inner leaf of wall construction is visible from within attic space duo pitched roof section.
Methods used for area 2	Visual inspection of brick in attic space
Evidence gathered for area 2

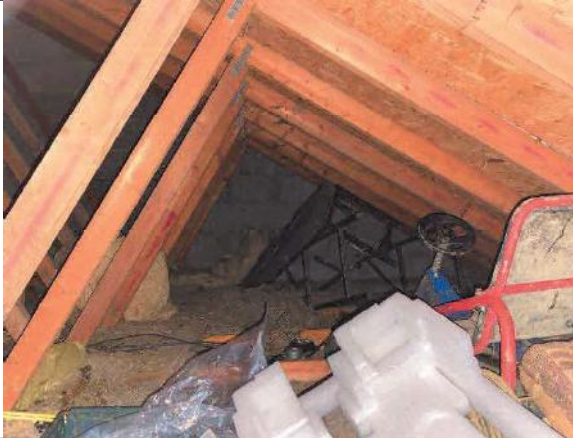
Conclusions for area 1	Timber trusses and timber ceiling ties are noted to the duo pitched roof. This confirms the use of structural timbers forming the main roof structure.
Area 2 inspected	Party wall construction is visible from within attic space duo pitched roof section.
Methods used for area 2	Visual inspection of blockwork in attic space
Evidence gathered for area 2

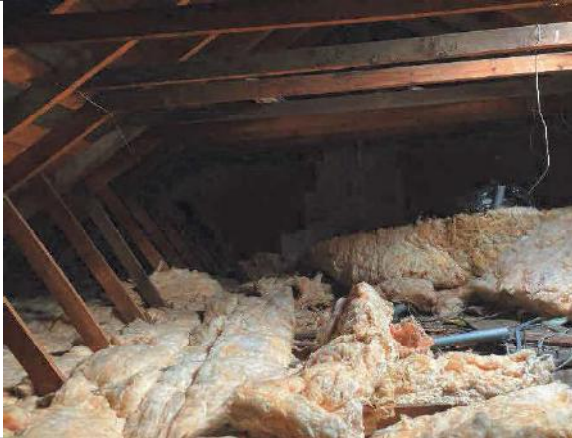
Conclusions for area 1	Timber trusses and timber ceiling ties are noted to the duo pitched roof. This confirms the use of structural timbers forming the main roof structure.
Area 2 inspected	Inner leaf of wall construction is visible from within attic space duo pitched roof section.
Methods used for area 2	Visual inspection of block in attic space
Evidence gathered for area 2

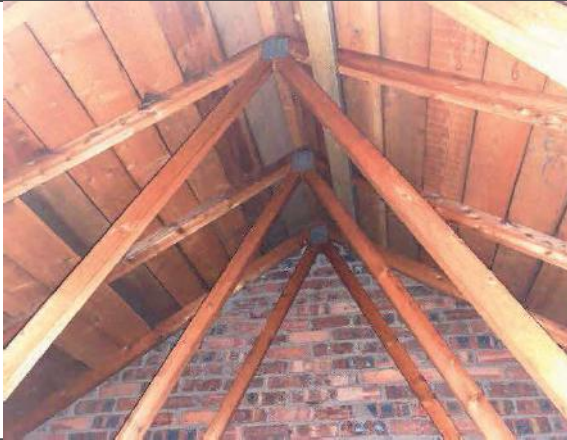
Conclusions for area 1	Timber trusses and timber ceiling ties are noted to the duo pitched roof. This confirms the use of structural timbers forming the main roof structure.
Area 2 inspected	Party wall construction is visible from within attic space duo pitched roof section.
Methods used for area 2	Visual inspection of brick work in attic space
Evidence gathered for area 2

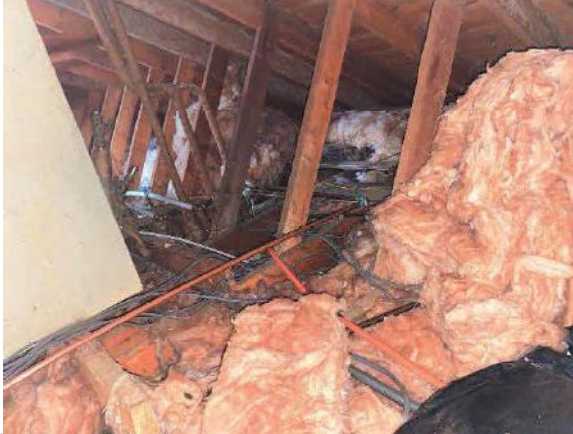
A photograph showing the interior of an attic space. It features a network of dark brown timber trusses and ceiling ties. There are large, irregular piles of orange-brown fibrous insulation material scattered throughout the space. The lighting is somewhat dim, highlighting the structural elements.
Conclusions for area 1	Timber trusses and timber ceiling ties are noted to the duo pitched roof. This confirms the use of structural timbers forming the main roof structure.
Area 2 inspected	Inner leaf of wall construction is visible from within attic space duo pitched roof section.
Methods used for area 2	Visual inspection of brick in attic space

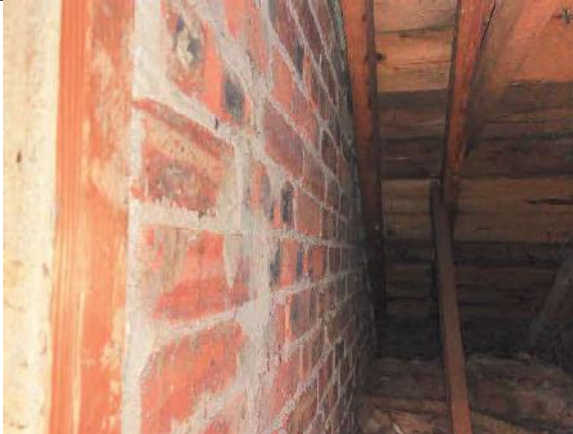
A close-up photograph of a brick wall. The bricks are reddish-brown with visible mortar joints. The wall appears to be part of a larger structure, with wooden framing visible in the background. The lighting is focused on the brickwork, showing its texture and color.
Conclusions for area 2	Clay brick is present as the inner leaf of the main wall construction. RAAC panels are not present.

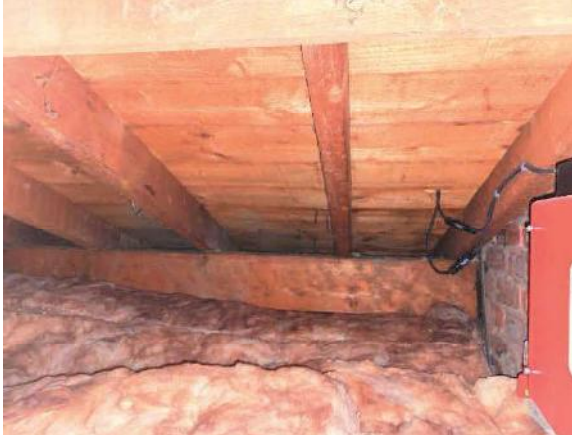
Conclusions for area 1	Timber trusses and timber ceiling ties are noted to the duo pitched roof. This confirms the use of structural timbers forming the main roof structure.
Area 2 inspected	Party wall and inner leaf construction is visible from within attic space duo pitched roof section.
Methods used for area 2	Visual inspection of brick work in attic space
Evidence gathered for area 2

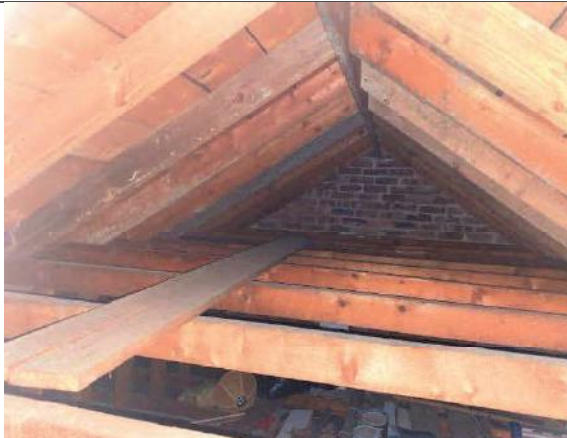
Conclusions for area 2	Clay brick is present as the inner leaf of the main wall construction. RAAC panels are not present.

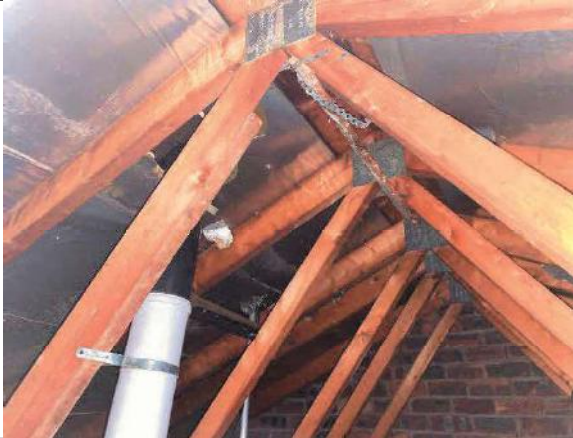
Conclusions for area 1	Timber trusses and timber ceiling ties are noted to the duo pitched roof. This confirms the use of structural timbers forming the main roof structure.
Area 2 inspected	Party wall construction is visible from within attic space duo pitched roof section.
Methods used for area 2	Visual inspection of brick work in attic space
Evidence gathered for area 2

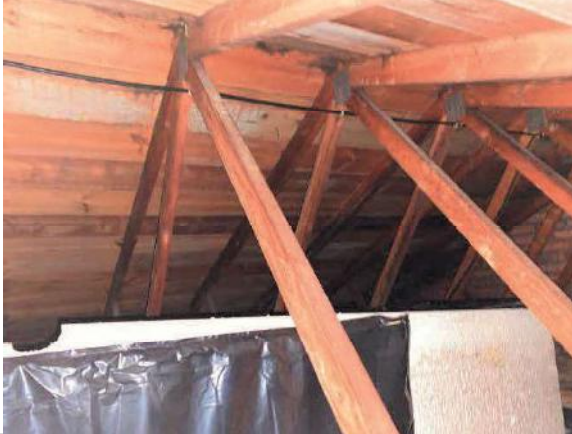
Conclusions for area 1	Timber trusses and timber ceiling ties are noted to the duo pitched roof. This confirms the use of structural timbers forming the main roof structure.
Area 2 inspected	Party wall construction is visible from within attic space duo pitched roof section.
Methods used for area 2	Visual inspection of brick work in attic space
Evidence gathered for area 2

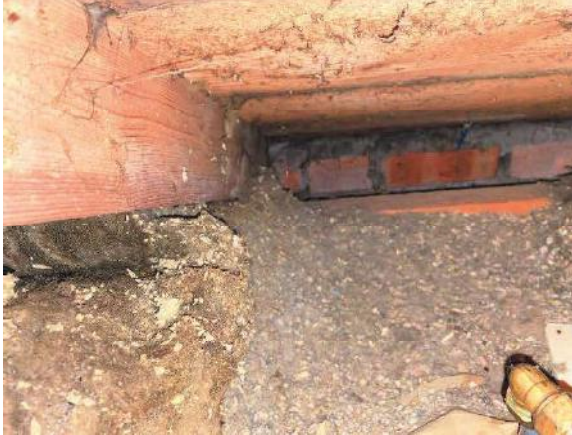
Conclusions for area 2	Clay brick is present as the external walls of the main wall construction. RAAC panels are not present.

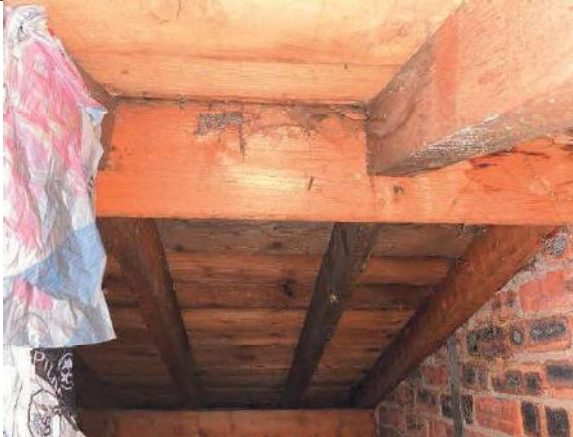
Conclusions for area 1	Timber trusses, timber purlins and timber ceiling ties are noted to the duo pitched roof. This confirms the use of structural timbers forming the main roof structure.
Area 2 inspected	Party wall and inner leaf construction is visible from within attic space duo pitched roof section.

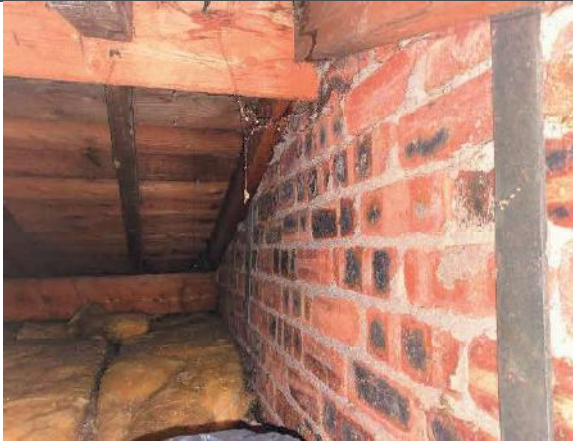
Conclusions for area 2	Clay brick is present as the party wall and inner leaf of the main wall construction. RAAC panels are not present.
Area 3 inspected	Underside of property to front elevation at location of the car port where concrete slabs are present
Methods used for area 3	Visual inspection of car port and hammer test of the concrete elements
Evidence gathered for area 3

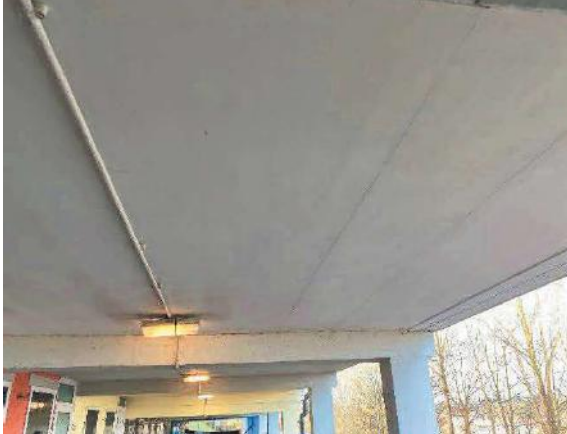
Conclusions for area 3	The concrete slab below the property at the location of the car port is reinforced concrete beams and columns supporting a series of precast beams. Hammer test showed that concrete produced a solid “ping”, and no indentations of soft spots were encountered. No RAAC concrete present based on findings.

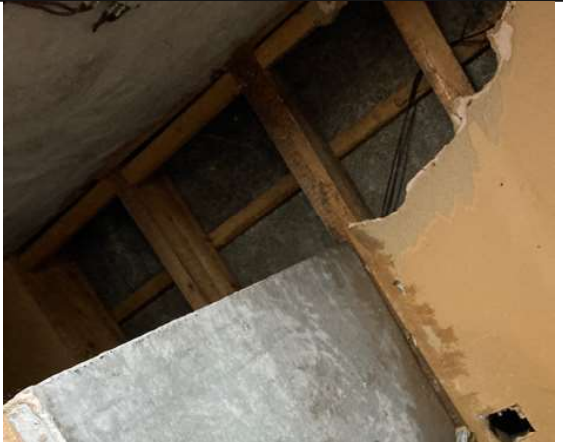
Conclusions for area 1	<p>Timber joists confirmed by visual inspection. A dense concrete ceiling is present to the stairwell at a level below the roof. Aggregate was visible in this material which would not be present in RAAC.</p>

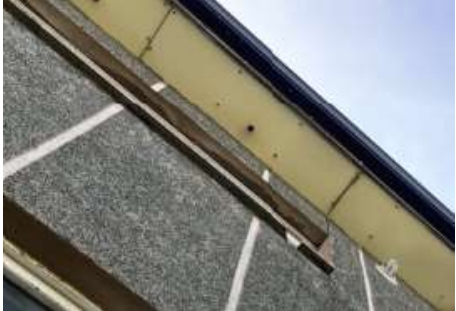
Conclusions for area 1	The appearance of soffit boarding rather than exposed concrete planks, combined with the plasterboard lining to the stairwell ceiling indicate a timber joisted roof construction.
Area 2 inspected	Render panels with vertical lines
Methods used for area 2	Visual inspection only.
Evidence gathered for area 2

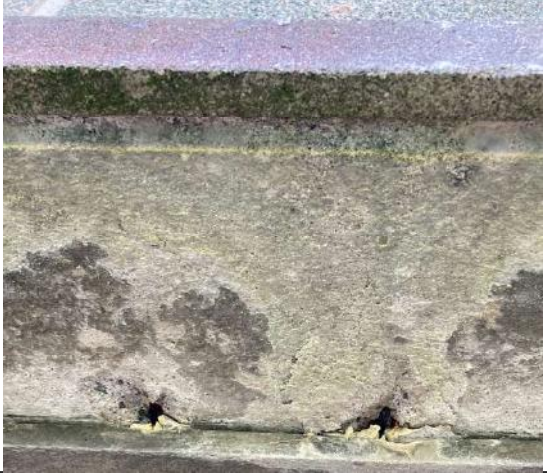
Conclusion for area 2	Aggregate visible to concrete edging, and brick visible below render on various areas. No RAAC present.

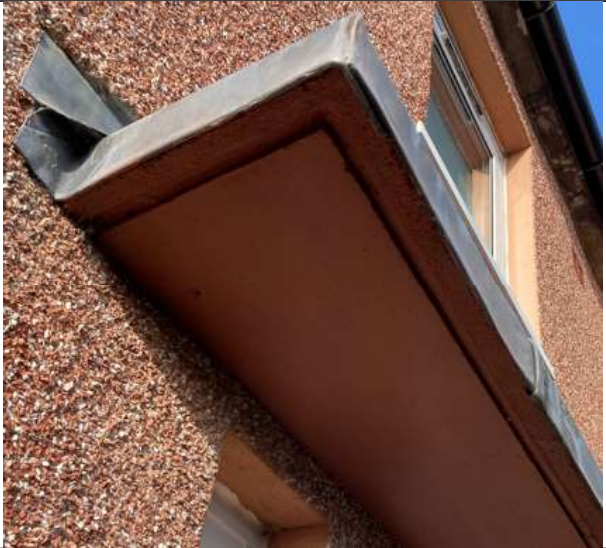
Conclusions for area 2	Dense concrete was confirmed with aggregate visible and refusal of a sharp tool. RAAC not present.

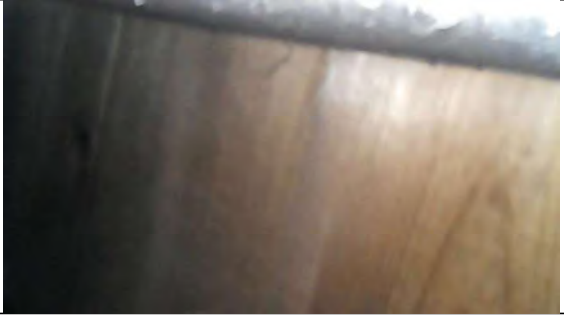
Conclusions for area 1	Timber boarding above void and sides of joists visible via inspection hole, with associated void. This demonstrates that there are structural timber joists forming the stairwell roof structure. It is deemed unlikely that an alternative roof structure is in use over the flats, differing from that over the stairwell.
Area 2 inspected	Wall construction is visible to the corner of the rear wall within the stairwell where masonry is visible behind the render
Methods used for area 2	Visual inspection of brick edge
Evidence gathered for area 2

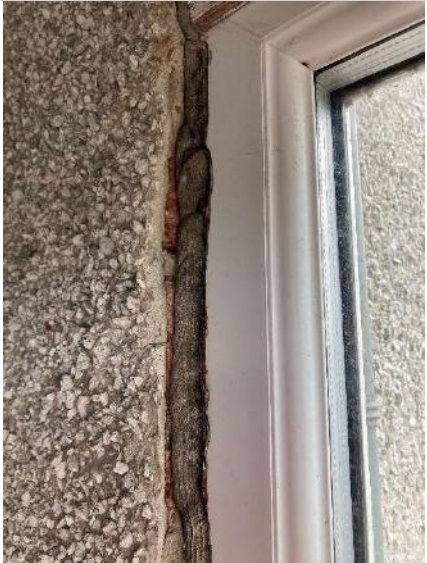
Conclusions for area 2	Clay brick is present below the render finish to include areas with the panelled finish. A RAAC panel is not present.

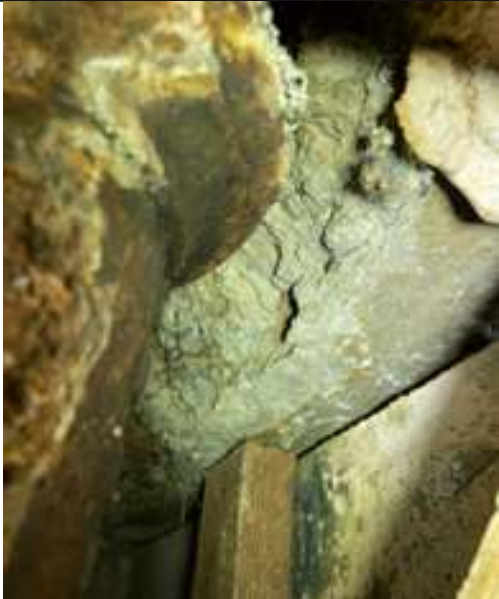
Conclusions for area 1	A dense concrete roof is present to the flat unit inspected. Aggregate was visible in this material which would not be present in RAAC.

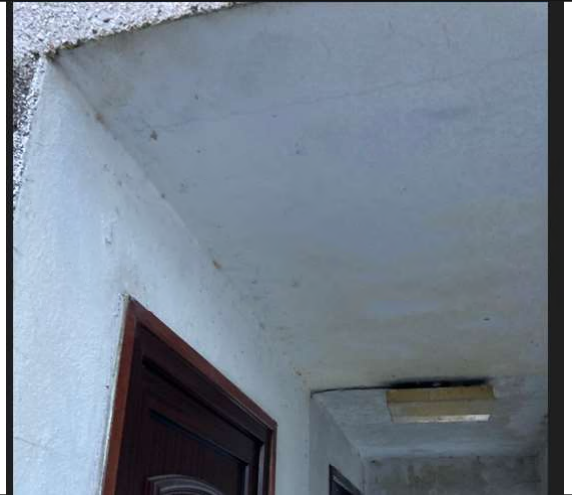
A dense render is present to the underside of the roof. This was confirmed with a penetration test using a sharp tool. There is no evidence of precast panels being used in the roof construction in the forms typical of RAAC. i.e. Panel edges are not visible to suggest a precast plank is used. We conclude that RAAC is not present.

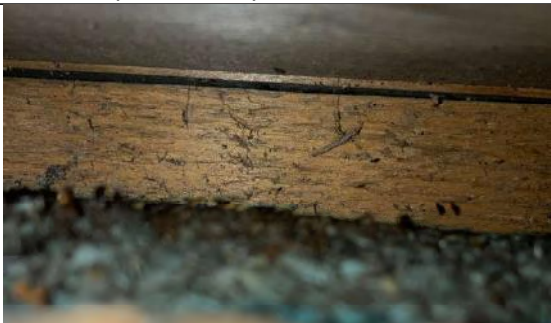
Timber joists confirmed by visual inspection.
No concrete structure to roof.

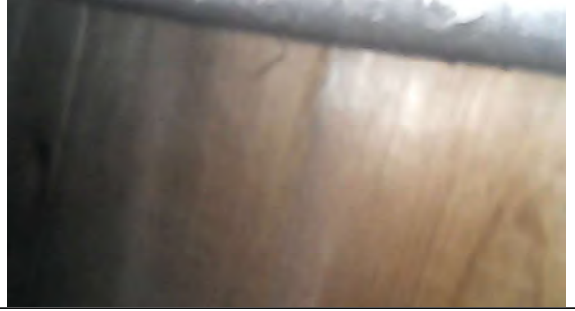
Timber joists confirmed by visual inspection.
No concrete structure to roof.

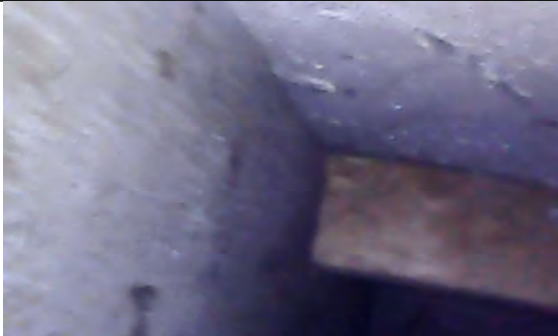
Conclusions for area 1	Timber joists at regular spacing, confirmed by visual inspection, with roof boarding over. RAAC not present.

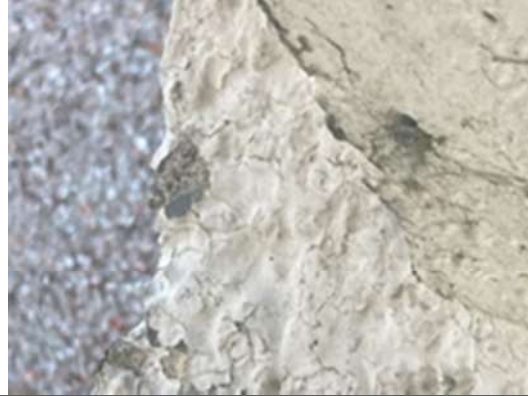
It was possible to see aggregate in the concrete which indicates that a dense concrete is present. This was further confirmed with a penetration test on the concrete which resisted penetration from a sharp tool.

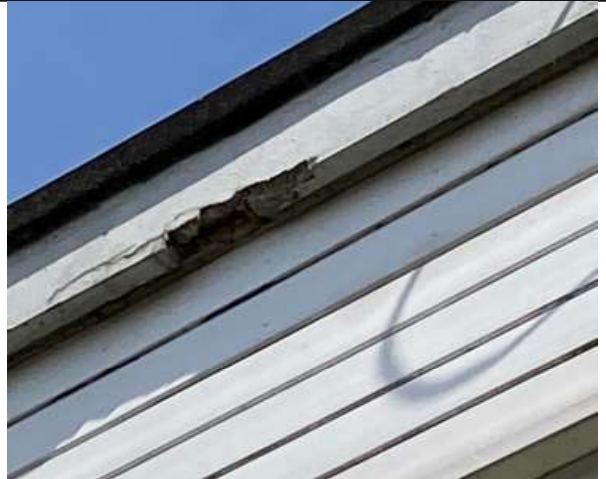
Dense concrete was confirmed at eaves with visible aggregate . RAAC not present.

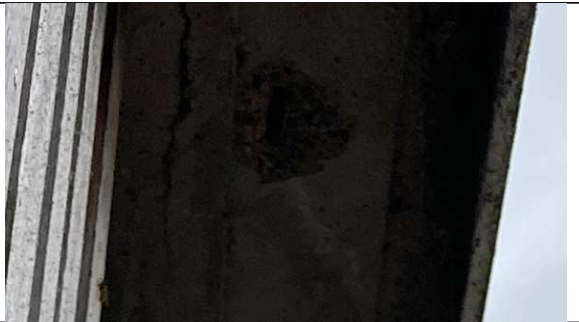
A dense concrete roof is present. Aggregate was visible in the concrete soffit which would not be present in RAAC.

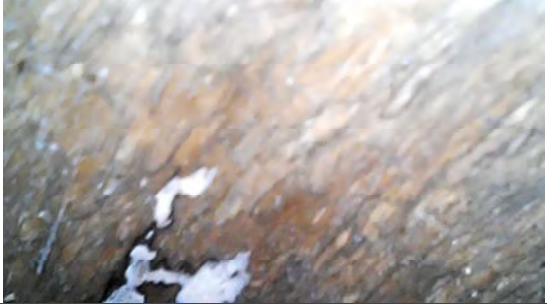
Conclusions for area 1	Void found between timber joists with a timber boarding over. Confirms roof is formed with timber joists at regular centres.

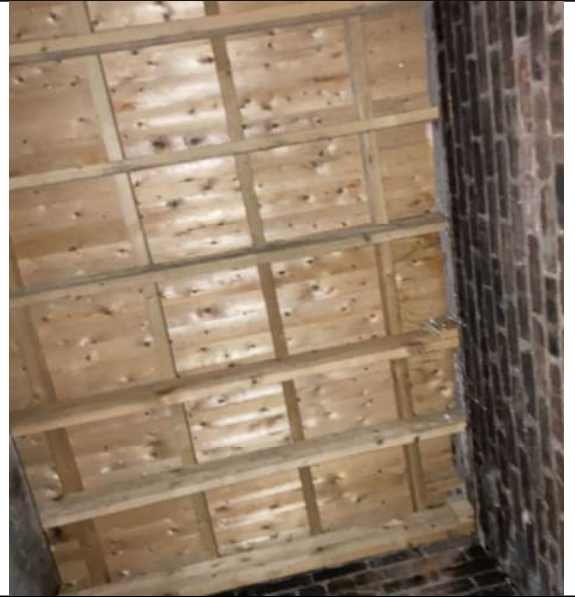
Timber joists confirmed by visual inspection. A dense concrete ceiling is present to the stairwell at a level below the roof. Aggregate was visible in this material which would not be present in RAAC.

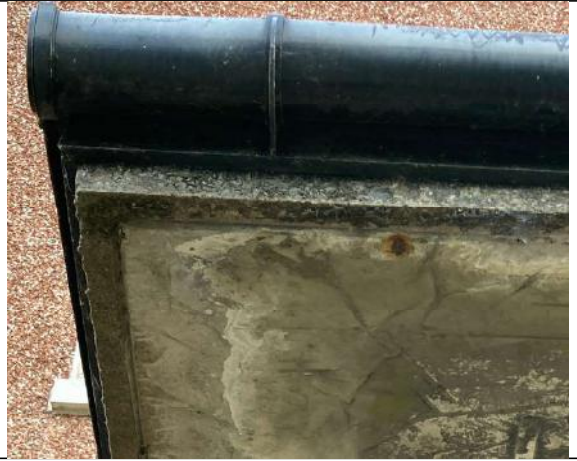
A dense concrete roof is present to the canopies. Aggregate was visible in this material which would not be present in RAAC.

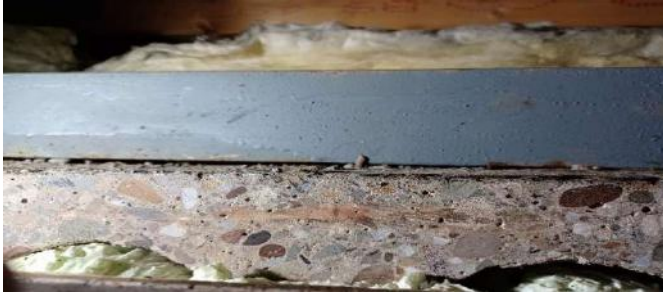
The image below from the property shows the precast concrete and provides assurance that RAAC is not present.

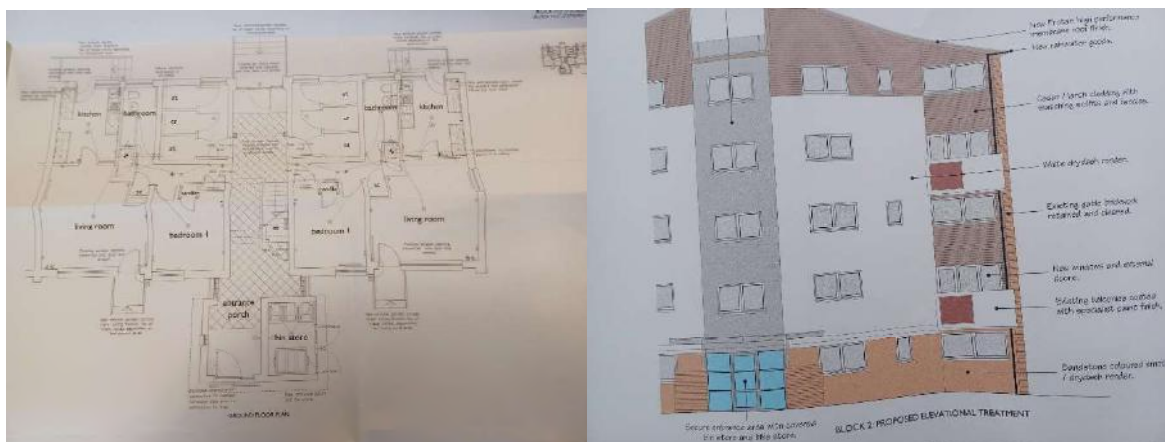
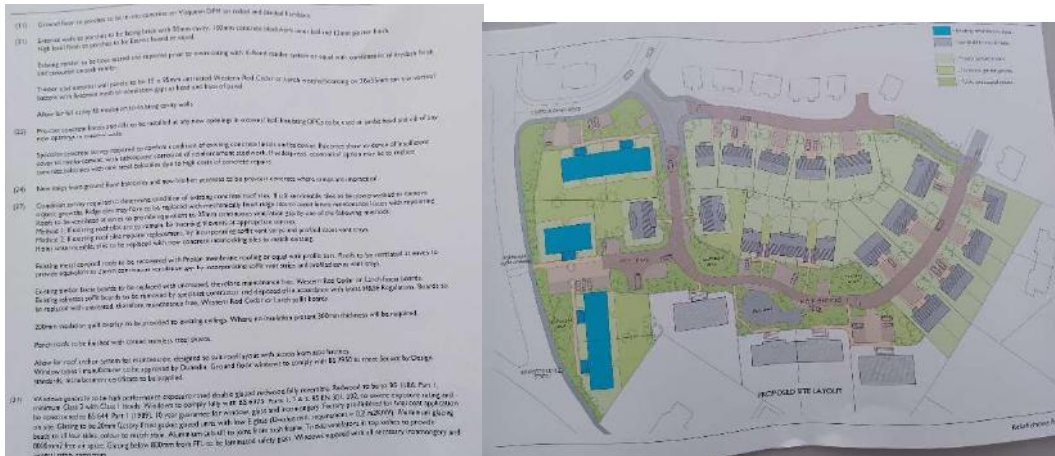
These properties were built the Gilmerton area of Edinburgh in 1965, and were part of a full regeneration programme with the work being carried out between 2007-2012

A full desk top review was carried out on our paper-based file information relating to the properties. An extract of this is provided below confirming the traditional build nature and there is nothing to suggest use or presence of RAAC.

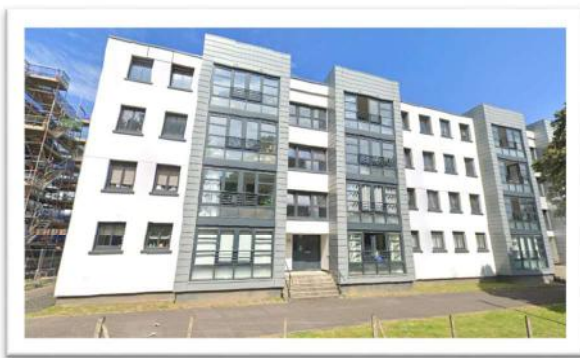
Shawbridge Street:

Five of these blocks are at Shawbridge Street in Glasgow.

These were built in 1967 with a flat roof made of a concrete slab. The building was fully remodelled and refurbished in 2015. There is nothing to indicate the presence of RAAC.

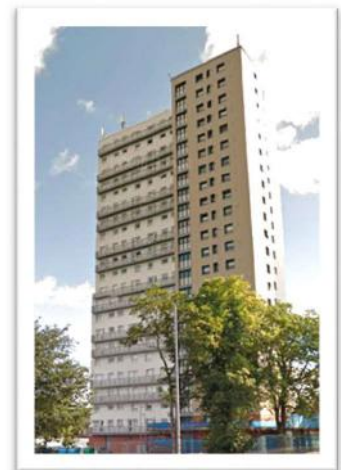
Ibroxholm Oval is a multi-storey flat in Glasgow. As discussed above in relation to the multi-storey flats which Wheatley Homes Glasgow owns, this block, which was built in 1965, has a concrete slab roof.

The building was fully remodelled and refurbished in 2013.

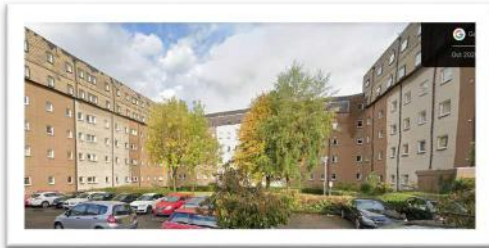
10 Dorset Square, Glasgow:

Loretto only has one flat in the development, as such detailed plans are not available, although desktop assessment indicates that this is a Mansard style roof and as such would be timber construction with slate finish. As such there is no reason to suggest presence of RAAC.

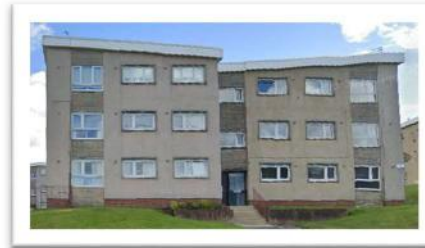
15 Bonnyton Lane, Hamilton:

Loretto only has one flat in block, as such detailed plans are not available, although, Wheatley Homes Glasgow has similar properties, from same period, with 6" concrete slab roof. As such there is no reason to suggest presence of RAAC.
